CIVIL CONSULTANTS MEMORANDUM

SUBJECT: Structural Evaluation of Town of Berwick Fire Station

DATE: APRIL 12, 2011

PROJECT: 10-225.00 TOWN OF BERWICK / FIRE STATION

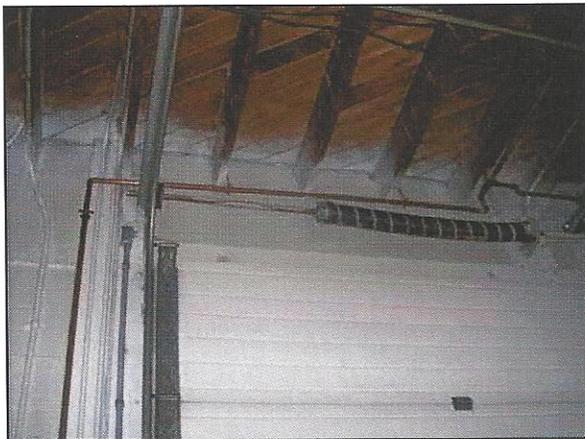
Using current building code standards, the area is assumed to be a heavily loaded classroom and should be capable of supporting 50 psf. Inspection of the joists does not indicate any failed members. It was observed during the inspection that the floor exhibits noticeable flexing under normal use due to the long spans.

Typical 2nd floor joist bearing at CMU wall.

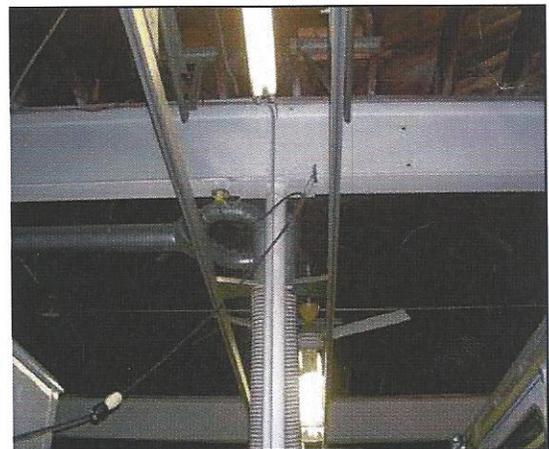
Typical 2nd floor beam-column connection.

The steel beams supporting the joists have adequate capacity to support the minimum live load, but are not connected to the supporting pilasters. This lack of connection is unacceptable and should be addressed through the installation of anchors or brackets having a secure connection to the pilasters and/or CMU wall.

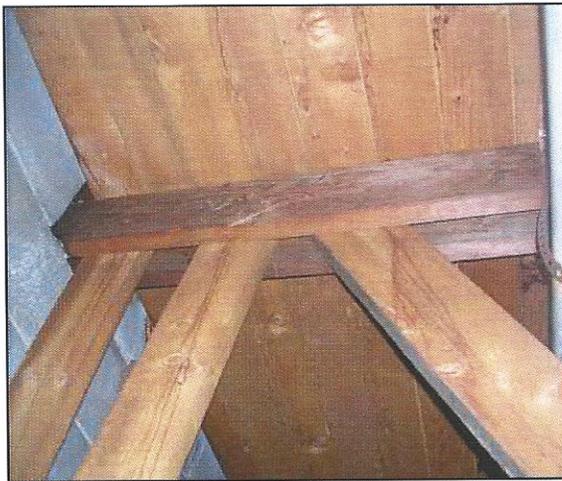
As noted in the previous report, moisture staining was observed in many areas of the roof framing, with the majority of truss members at the CMU wall exhibiting signs of exposure to water. While significant damage of the bearing ends was not evident, the presence of moisture has reduced the capacity of the timber in these locations.

Typical roof truss top chord bearing.

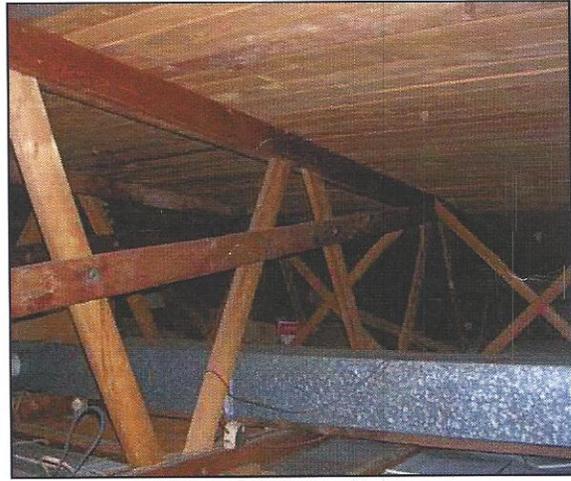
Analysis of the roof framing indicates that the existing 2x6 trusses are not adequate to support the current code minimum snow load. The capacity of the trusses has been further reduced due to cracking and splitting caused by poor timber quality and excessive stresses. Several truss members have failed and are no longer capable of carrying load, resulting in greater stresses in adjacent members and instability of the truss as a whole.

Typical timber roof truss.

The renovation to the trusses will be expensive. The redistribution of the stress due to the damage truss members has significantly reduced the load capacity. The probable renovation strategy is truss replacement. This renovation work needs to be balanced with other code required improvements.

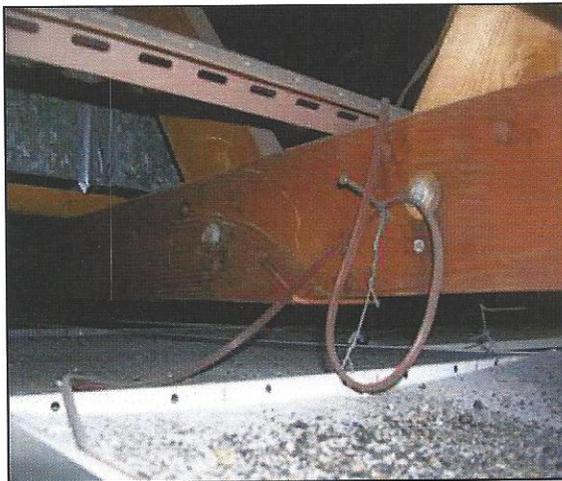
Review of eight of the twelve trusses reveal damaged and failing connections. The wood members are cracked through connections in several locations. These cracks compromise the load capacity of the truss members and roofing system. See the photographs and plans attached for details of the damaged truss members.

Bottom chord member in failure.

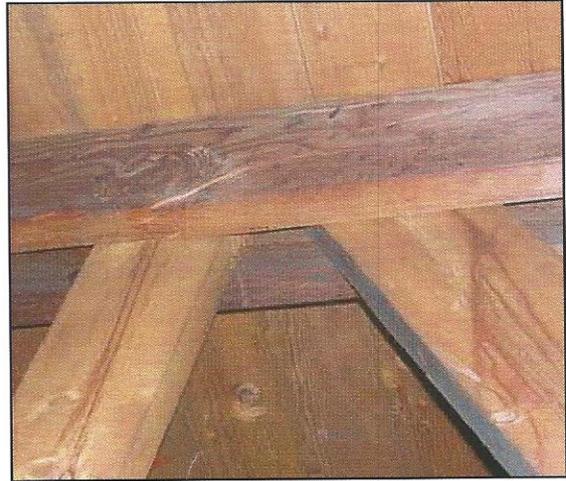
Top chord member in failure.

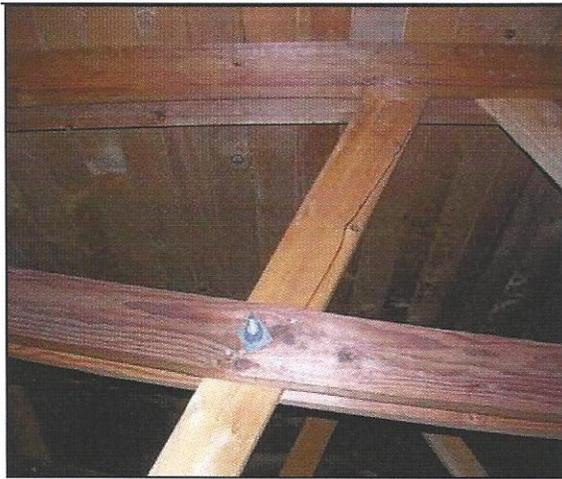
Web member with severe cracking.

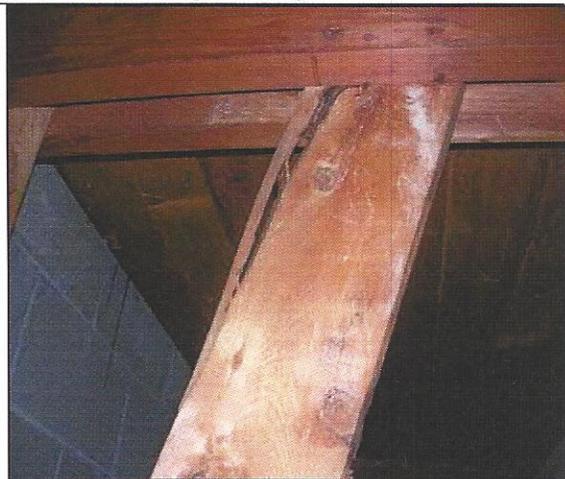
Web member in failure due to timber quality.

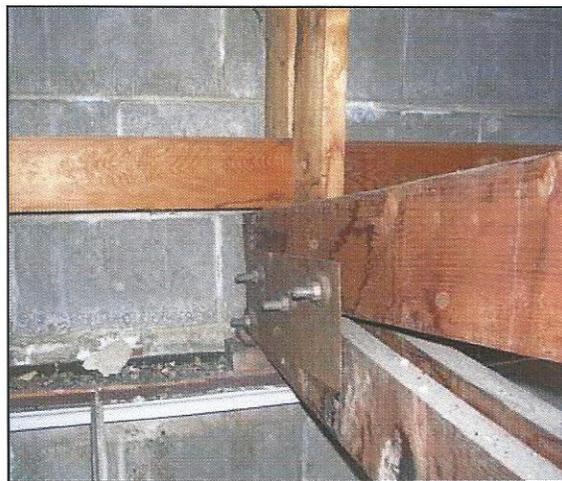
Bottom chord bearing with moisture staining.

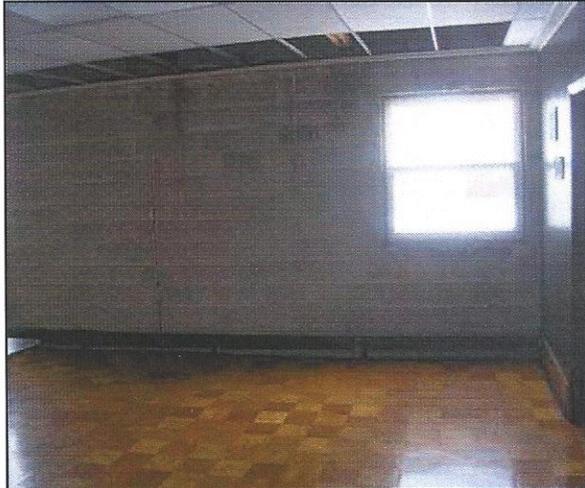
The visual inspection of the building from the main floor level reveals numerous vertical and staggered cracks along the masonry walls and concrete foundations. These types of cracks are characteristic of a building of this age. Typically, buildings of this age and type have minimal reinforcing in the concrete block walls. Over time, due to age, weather and settlement, the mortar

North CMU wall at second floor.

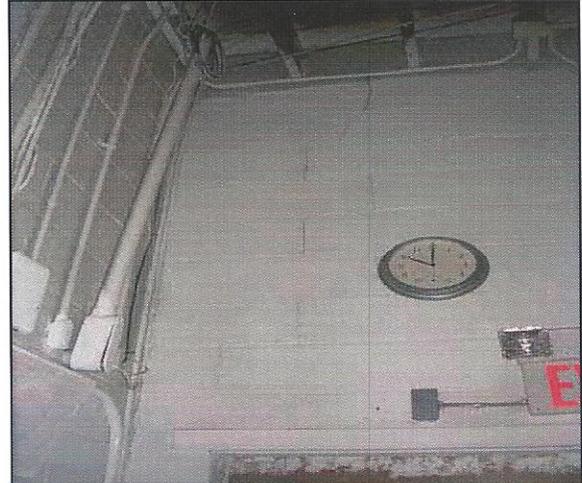
Cracking visible at front CMU wall.

The CMU cracks along the main entry door are typical for an under reinforced masonry wall. The cracks are caused by stress increases due to the floor framing and support of the main overhead doors.

The exterior brick work show signs of distress along the similar location of the interior block masonry. The cracks should be repaired to prevent further moisture intrusion. The repair should involve removal of the damaged mortar and replacement.
