Town of Berwick Fire Department Energy Assessment Report

2. Project Description

This report details the recommendations and findings of the audit report conducted for the Berwick Fire Department located at 10 School Street in Berwick, Maine. The site visits were conducted on July 20 & 28, 2011. At the time John Monaghan met with Chief Plant and Lt. Tibbits.

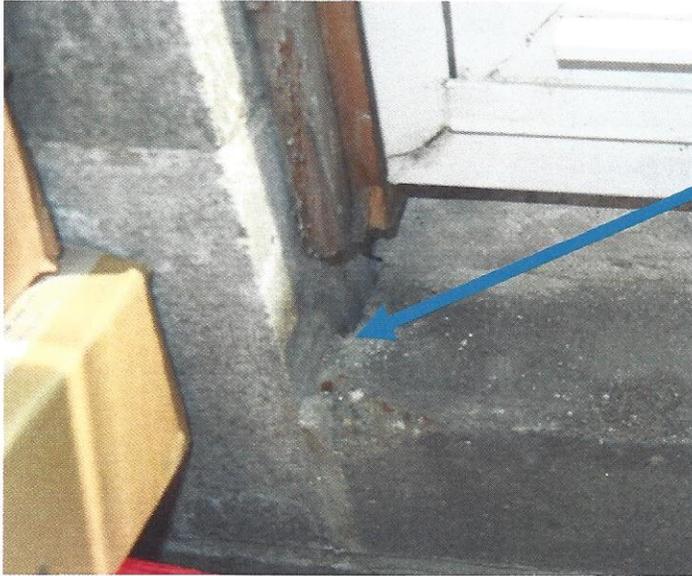
Picture to left shows voids at the jamb and no flashing.

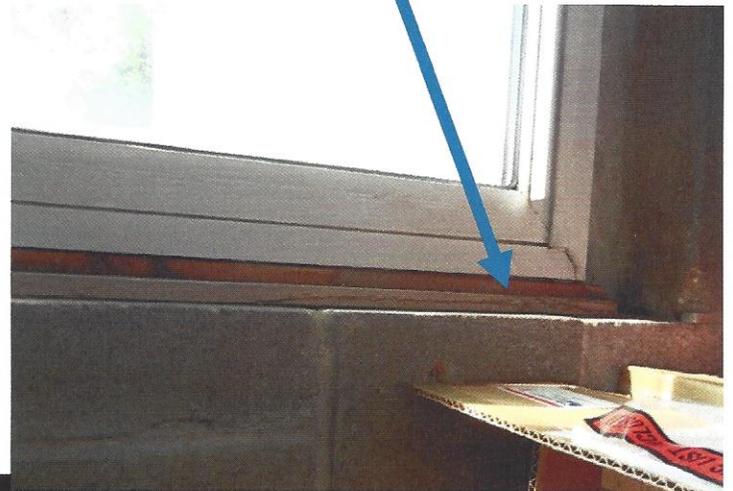
Picture below shows no sill flashing and signs of water intrusion

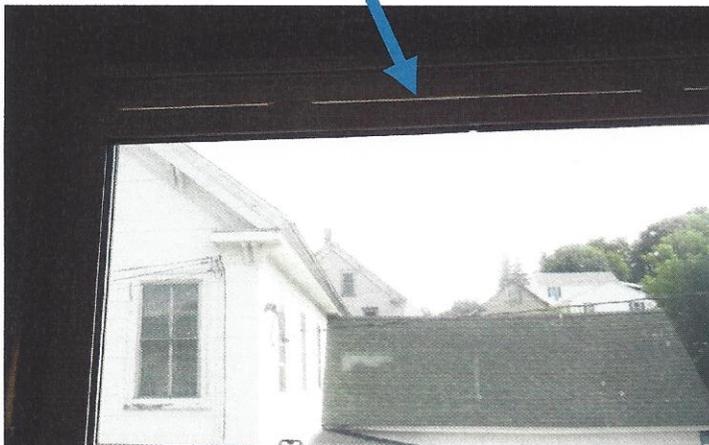
Picture below show voids at window frame allowing air and moisture to enter building and heat to escape

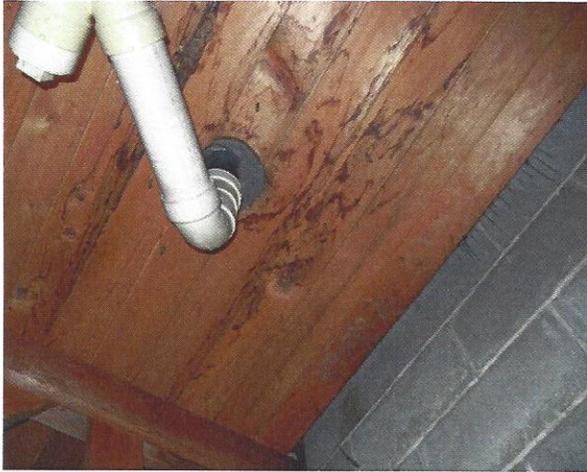
View of deck recommended to receive cell spray foam insulation. Tongue and groove deck is noted for air infiltration at joints. Spray insulation will correct this.

Penetrations, cracks, gaps and voids at the walls and ceilings are recommended to be air sealed. The tops of the block walls should have closed cell spray foam applied to seal them. The next recommendation is to add 3" of closed cell spray foam insulation at the underside of the roof deck and 2" of closed cell spray foam insulation at the band joist at the roof and masonry wall intersection. The spray foam shall have a coating that meets the State Fire Marshalls requirements. This will increase the roof R value to an estimated R-34 and the band

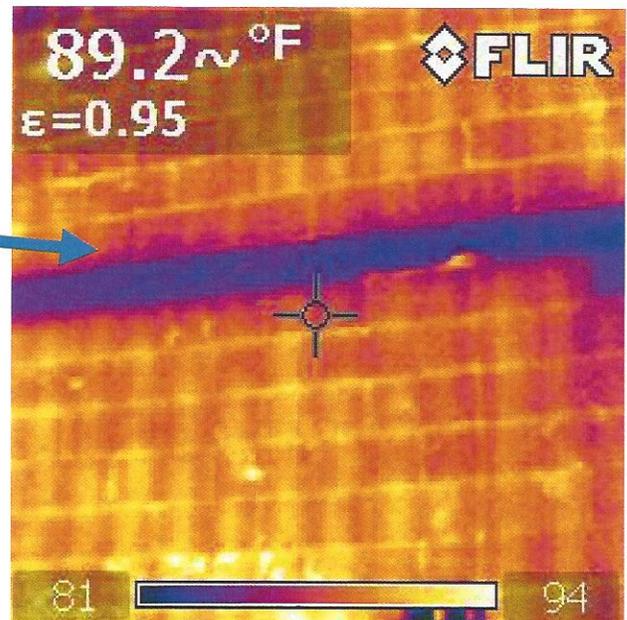
View of south wall, blue shows the floor line and joist. The blue represents a cooler surface that is recommended to receive closed cell spray foam.

Note if the wall had been grouted or reinforced it would have shown bluer because the core would be filled

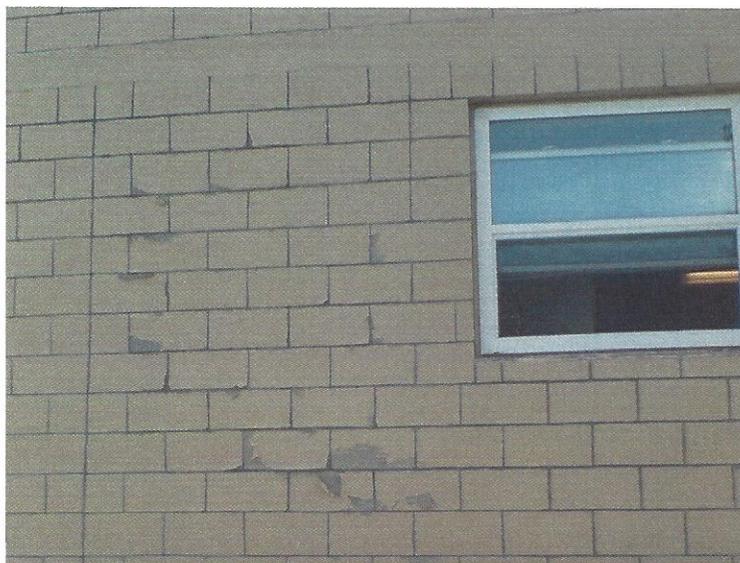
View of wall showing paint lifting due to driving force of moisture to the outside of the building

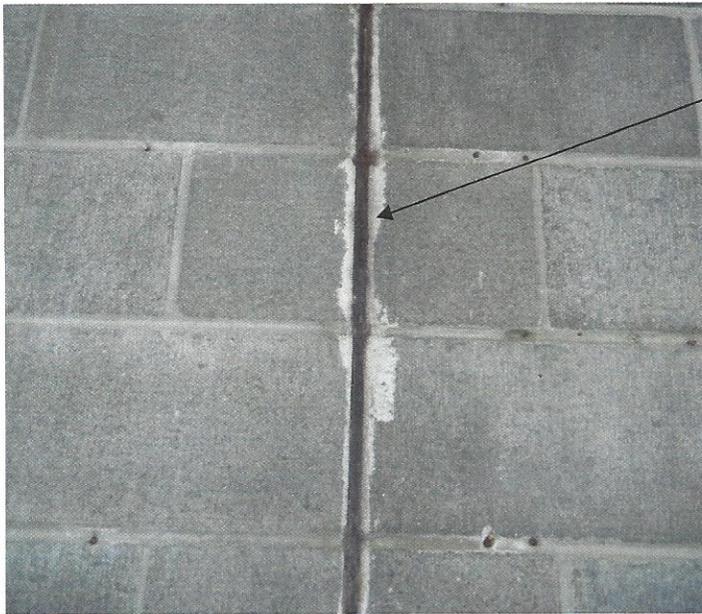
Interior view of expansion joint, a wood spacer was inserted, never removed for backer rod and caulking to be installed

No grout or reinforcing could be detected in the walls with the infrared camera or upon visual inspection. This was confirmed through information the town had obtained from the Structural Engineer. Considerable cracking and signs of movement were noted, and a lack of control or expansion joints were noted. These joints should be added based on the recommendation of the structural engineer. Both the new and existing joints should have backer rod and caulking applied to both faces of the wall.

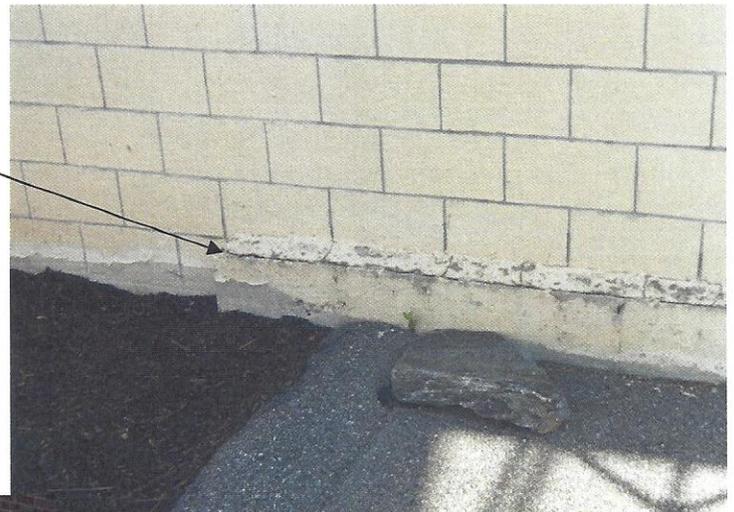
View to right shows mortar fillet at top of concrete foundation trying to be used as flashing. Note how loose and cracked it is.

This is not performing as flashing

In addition, where the masonry wall rests on the concrete foundation there is no flashing, and a mortar fillet that attempts to shed water likely does not work effectively. Correcting this will be difficult because the concrete wall is so close to the outside finished grade, however installing a termination strip with flashing wherever possible as well as a perimeter drain at the rear of the building will help.

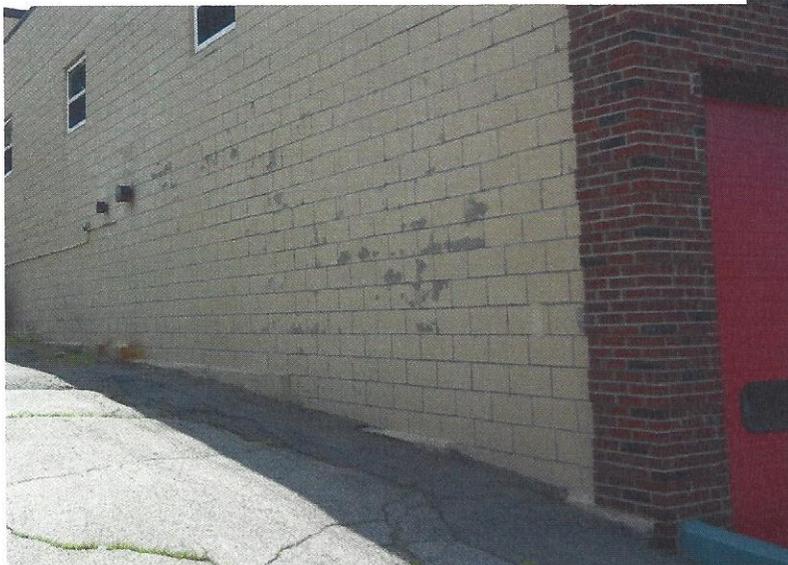
Below the view shows the steps in the concrete foundation with no flashing creating a point for water to enter. Also, note some steps are below grade, but there is positive drainage away from the building

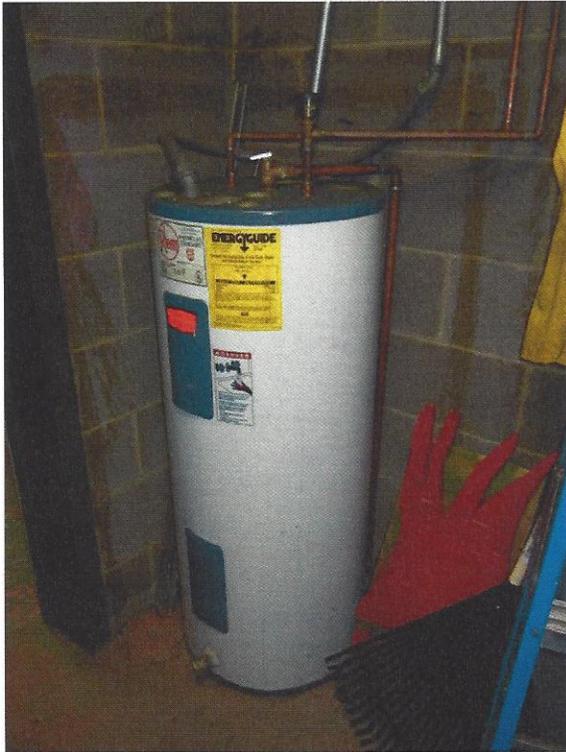
View of the 40 gallon electric hot water heater

In addition insulating the first 8 feet of hot water supply and cold water feed piping in the boiler room is recommended.

Based on the usage and projected cost savings it is recommended a seven day timer be added
