PN: 10-3206

September 1, 2010

Re: Asbestos Identification Survey for the Former Prime Tanning Facility Located in Berwick, Maine.

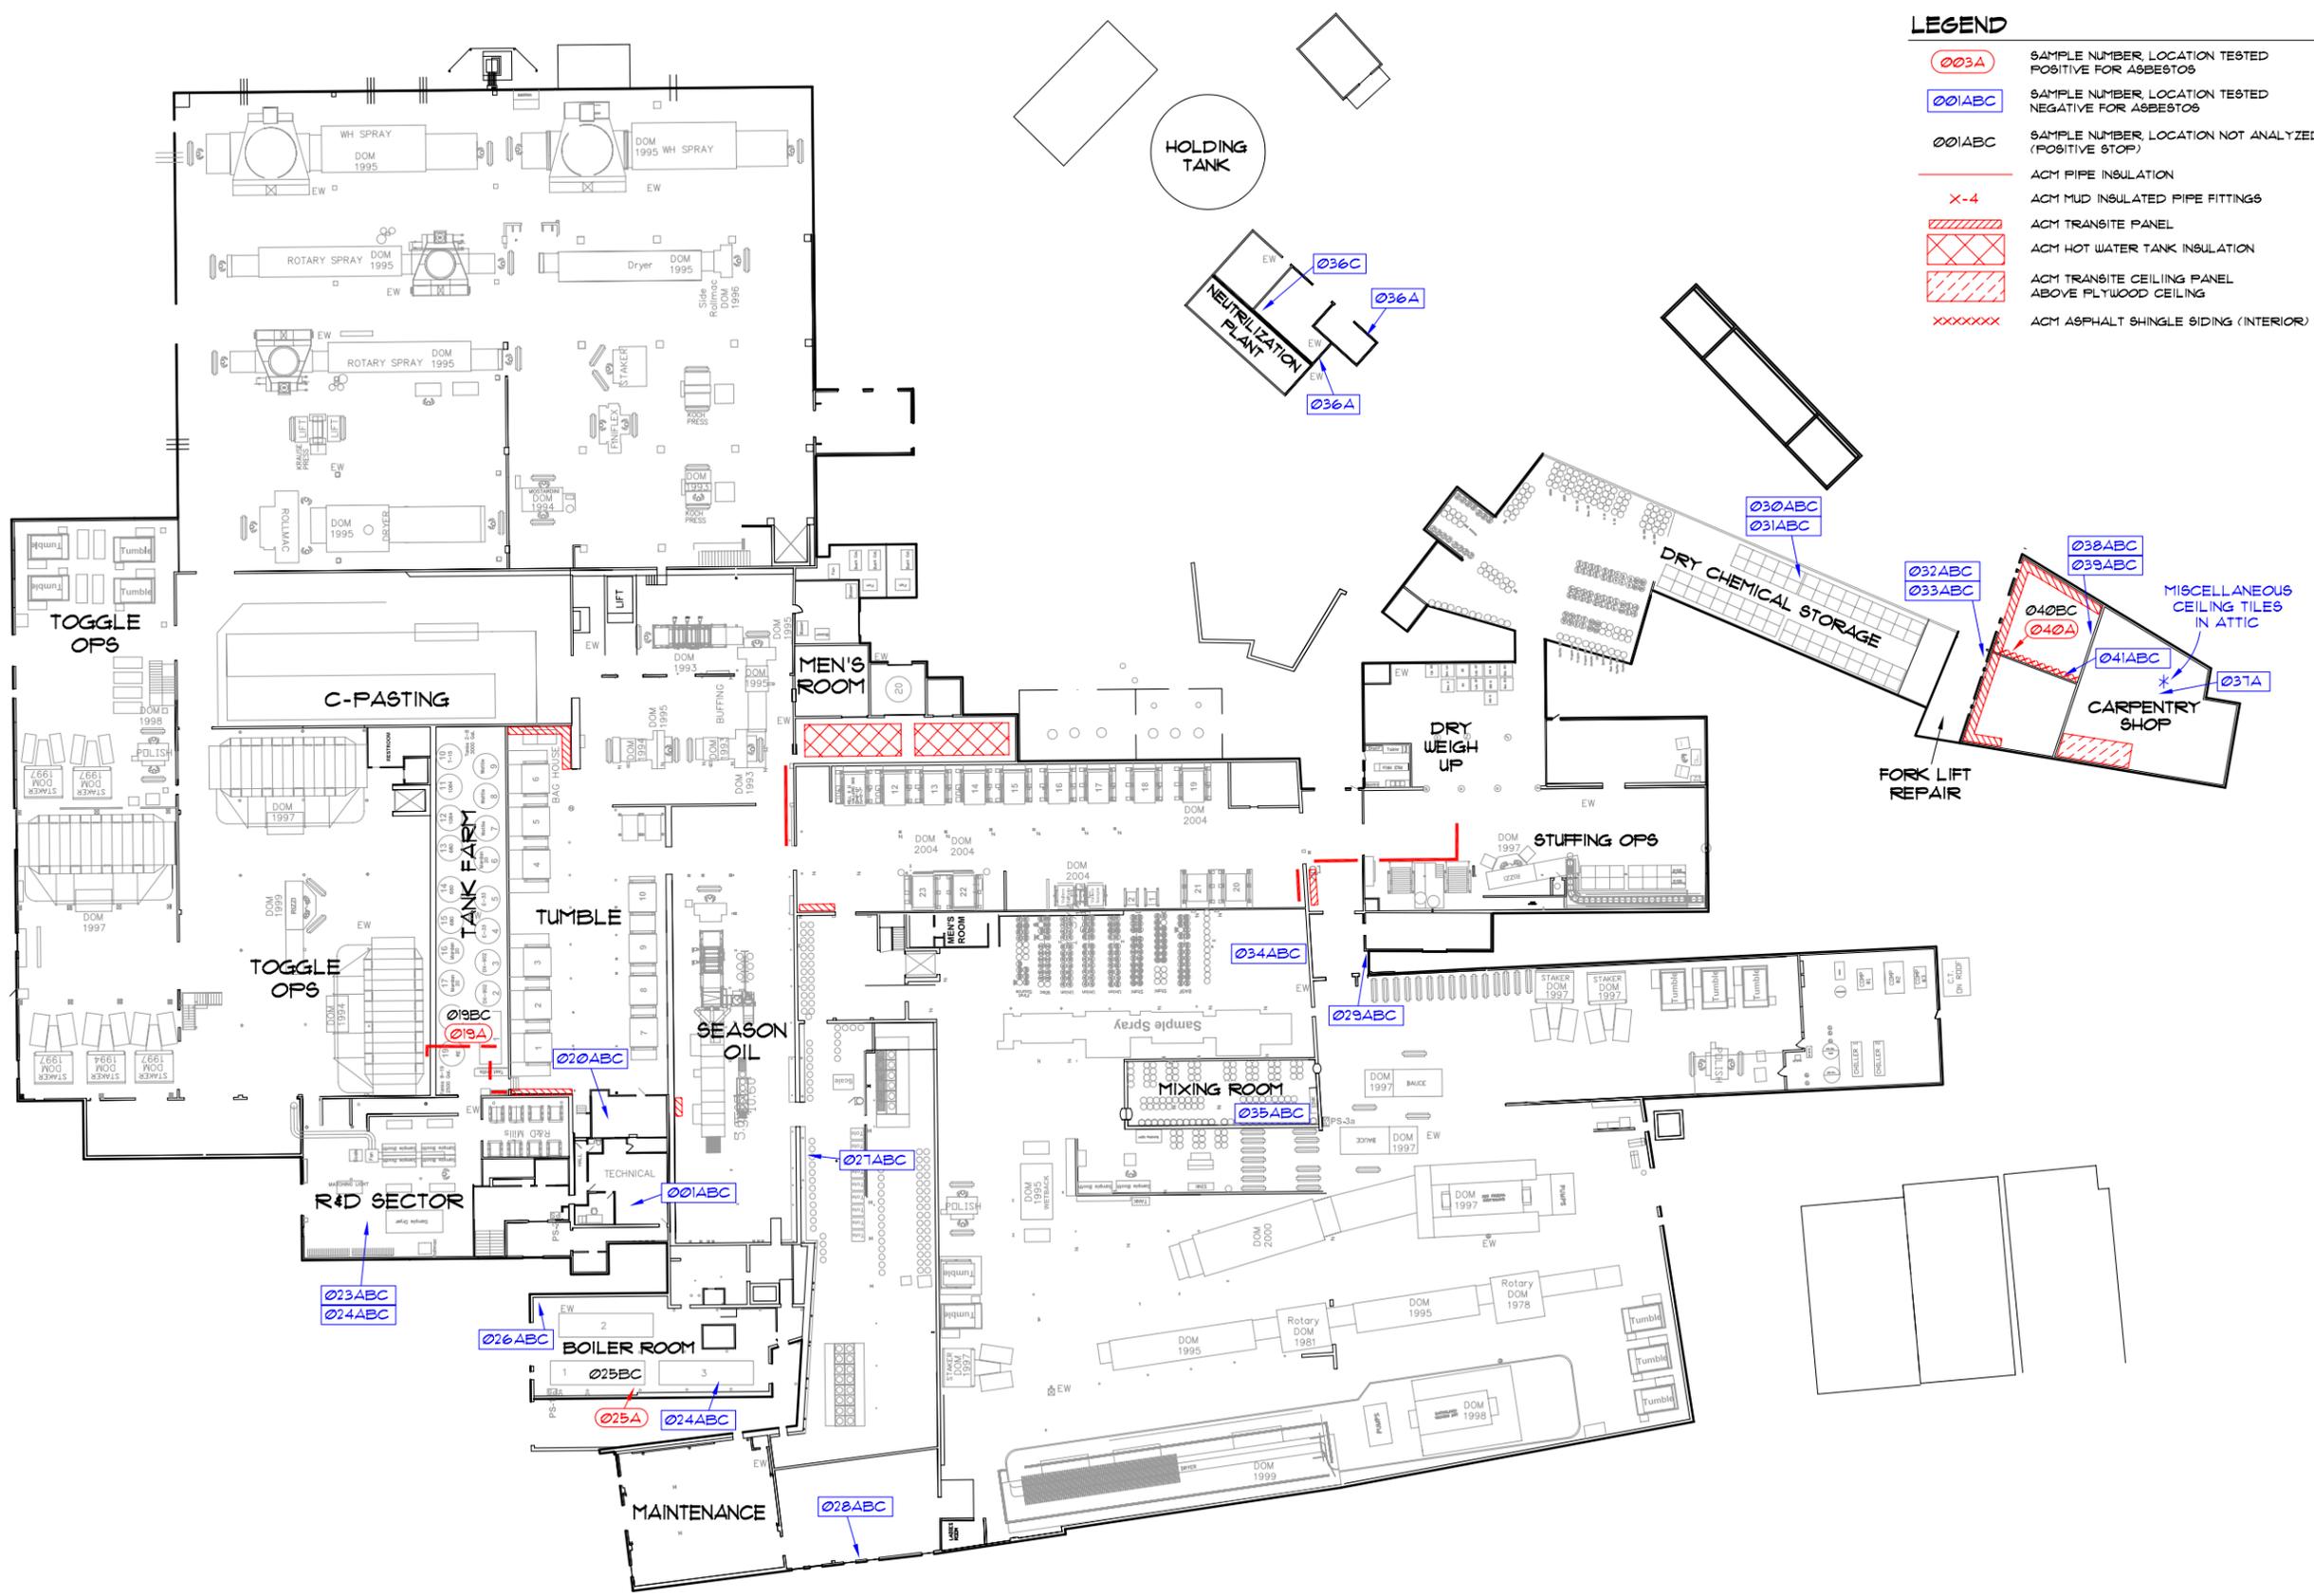
FIGURE 1
FIRST FLOOR

- Pipe insulation;
- Residual mudded insulation of pipe fittings associated with steam mains. The original fittings were reportedly previously removed by Abatement Professionals. Remaining fitting insulation in the Main Building was non-ACM;
- 9-Inch by 9-inch green floor tile and associated adhesive;
- Refractory mud under metal boiler cover;
- Brown asphalt siding on interior walls; and
- Gray asphalt siding on interior walls.

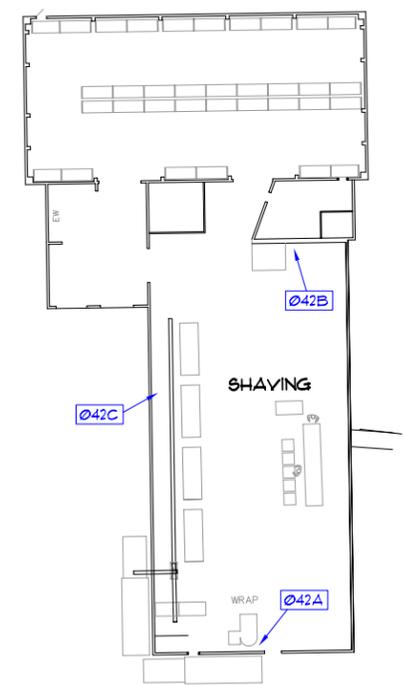
"WET BLUE" WAREHOUSE
SCALE: 1" = 25'

Laboratory analytical results indicated that asbestos was not identified in the suspect material sampled.
