ENVIRONMENTAL CONSULTING GROUP
St.Germain ▪ Collins

January 18, 2011

Re: Supplemental Site Investigation
Former Prime Tanning Property
20, 29, 34 and 35 Sullivan Street, Berwick, Maine
St.Germain Collins File No.: 3211.3

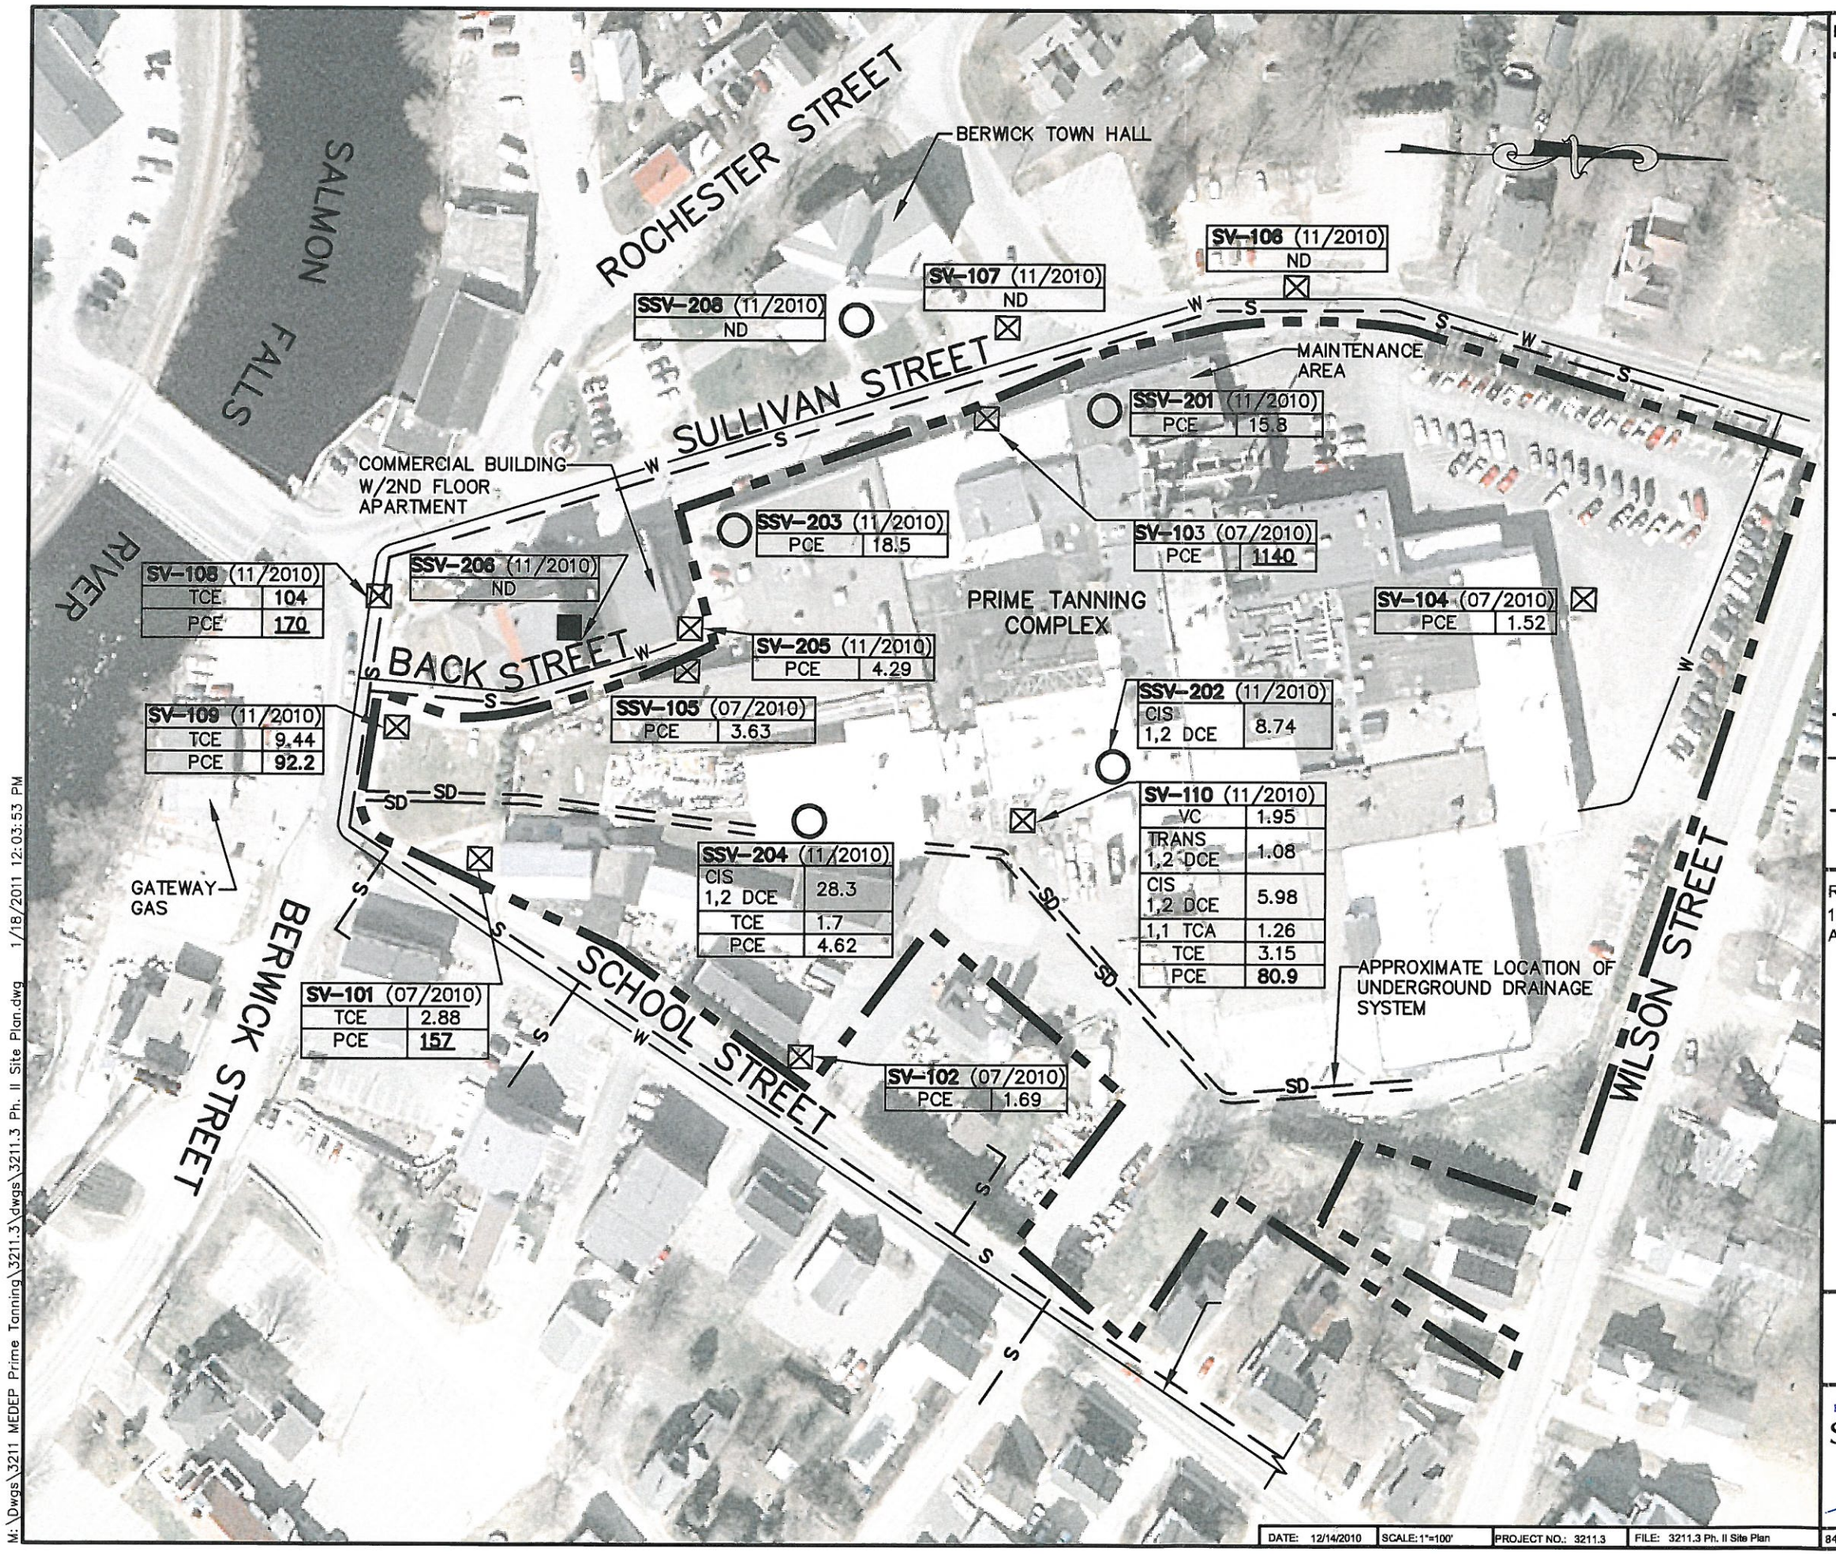
FIGURE 2

The Phase II ESA documented the presence of PCE contamination in soil vapor exceeding both the MEDEP residential and commercial Soil Gas Targets (SGT) for a multi-contaminate Site (see **Table 1, July 2010 Soil Vapor Sample Results)**. During the Phase II ESA five soil vapor samples were collected on the margins of the main tannery building. PCE exceeded the Residential and/or Commercial SGTs in two of the samples, SV-101 at a concentration of 157 ug/m^3 and SV-103 at 1,140 ug/m^3, and was detected in the other three soil vapor samples (SV-102, SV-104, and SV-105) at relatively low concentrations below the applicable standards (see Figure 2).

These sub slab and soil vapor results along with historical groundwater data for GW-108 indicate that the source of the PCE vapors is most likely below the main tannery building; however, the exact location could not determined based upon the concentrations reported in these samples. The migration of PCE vapors could be influenced by the presence of the subsurface drainage system along the southern edge of the property.

PCE and TCE were the only compounds that exceeded the Residential and/or Commercial SGTs in three samples (SV-108, SV-109, and SV-110) collected along Berwick Street and on Site during the November 2010 sampling. PCE and its breakdown compounds were detected in the other soil vapor samples but at relatively low concentrations and below the applicable standards. Based upon this sampling event and the July 2010 sampling it appears that the PCE contamination in the soil vapor is originating from below the Main Tannery Complex on Site.

1) Conduct additional soil vapor sampling to further assess the vapor intrusion threat to nearby receptors located south of Site.
