Hazardous Building Materials Survey Report

Prime Tanning Facility
20 Sullivan Street
Berwick, Maine

September 26, 2016

In Reference to:
Credere Project No. 15001312

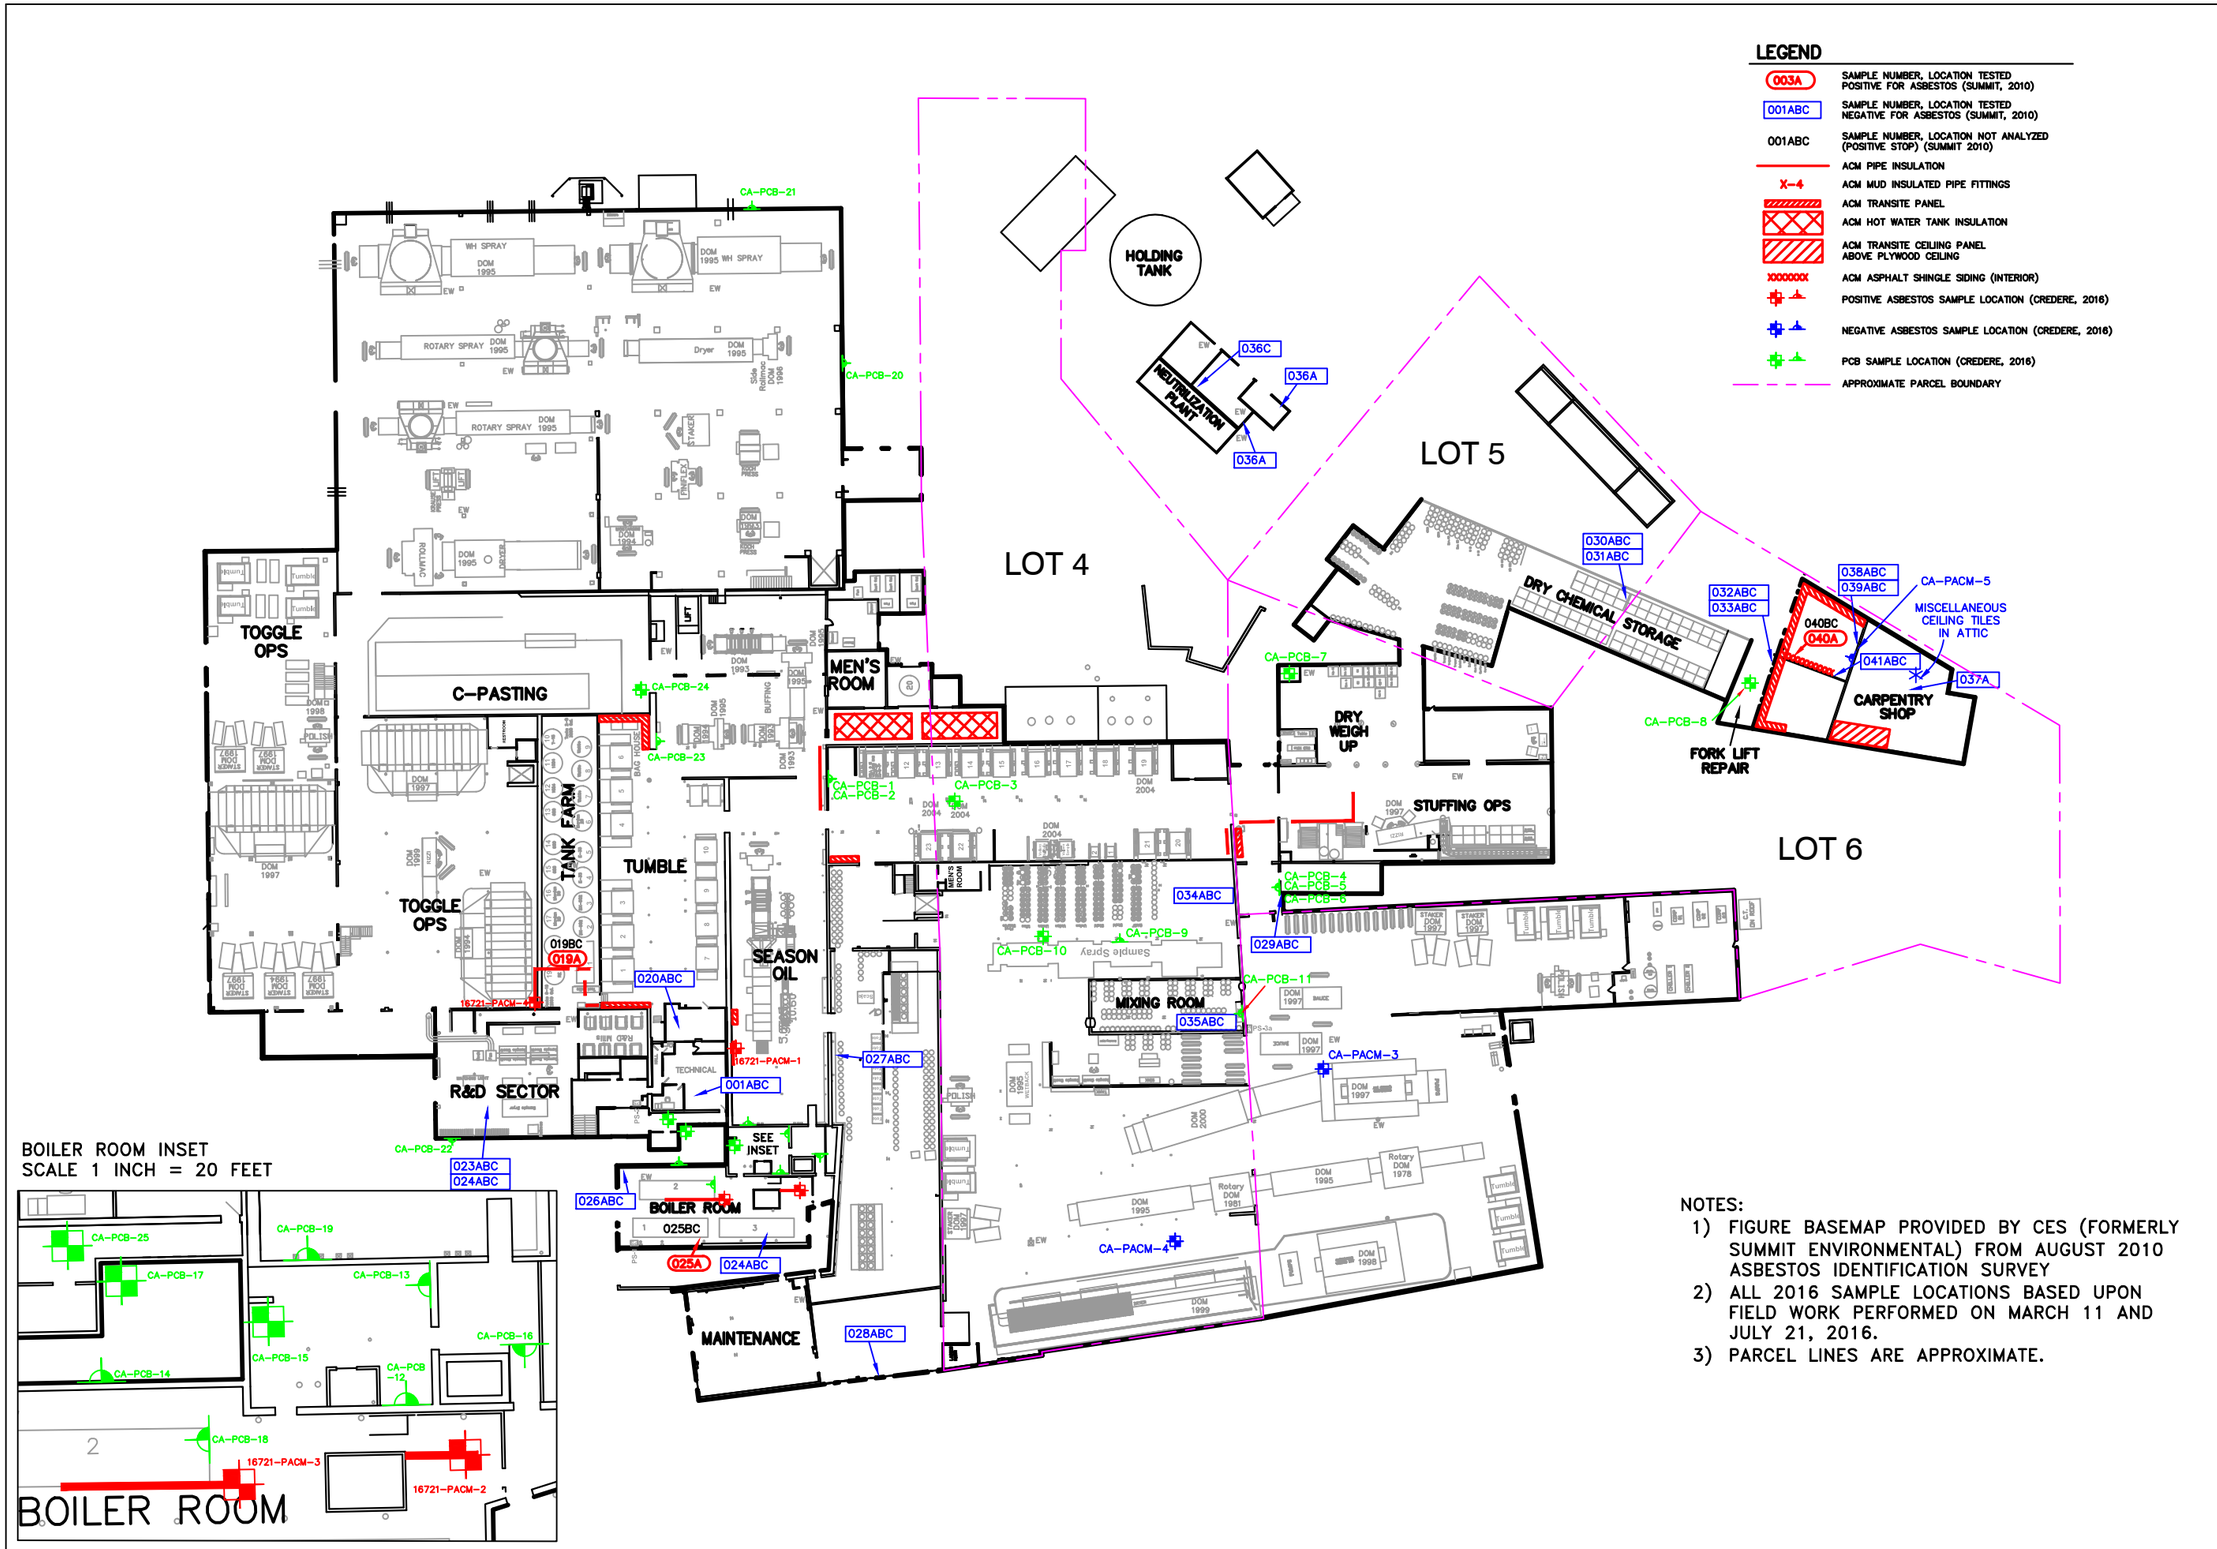
FIGURE 2
HAZARDOUS BUILDING MATERIAL SURVEY LOCATIONS
FIRST FLOOR INTERIOR

All suspect ACM sampled is described in **Table 1**, sample locations are depicted on **Figures 2 through 4**. Materials that were identified as positive as ACM are shown in bold in **Table 1**. Laboratory reports for the suspect ACM samples are included as **Appendix B**.
