Berwick Downtown Vehicle, Bicycle, and Pedestrian Study

Berwick, Maine
4/30/19

Prepared by:
MILONE & MACBROOM, INC.
121 Middle Street, Suite 201
Portland, Maine 04101
(207) 541-9544
www.mminc.com
with *James Tasse Consulting, LLC*
Bike Facility Planning

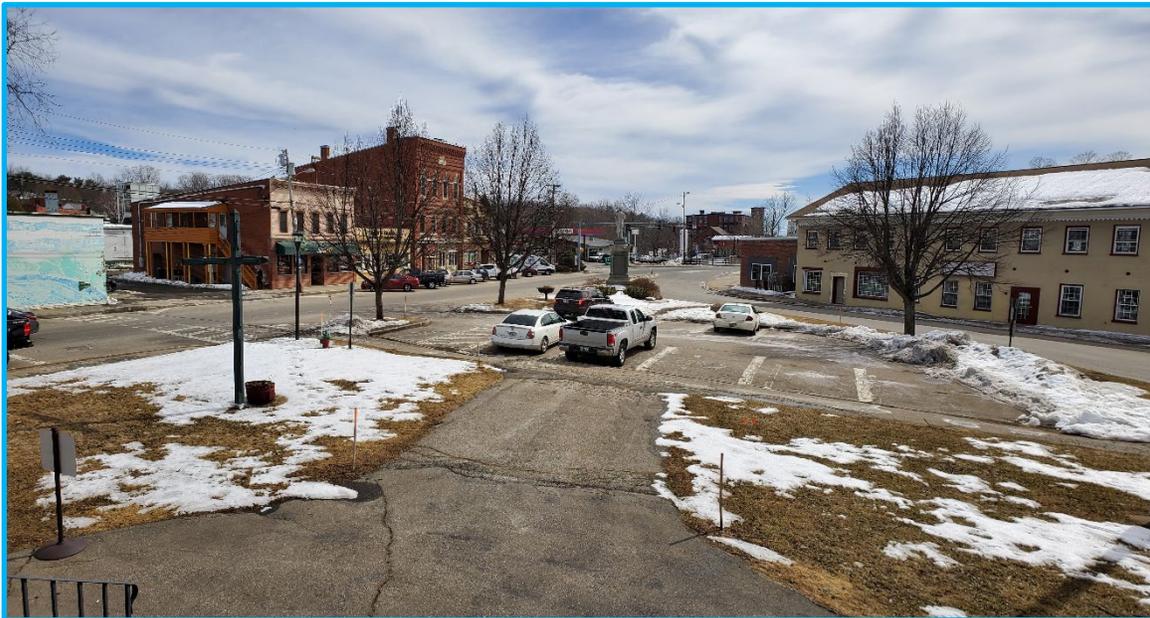
- All five crashes involved a driver failing to stop at a stop sign.

There is a clear pattern of crashes for this intersection with drivers failing to stop at the intersection. It is recommended that additional study be conducted for this intersection in order to improve driver compliance. Design-based improvements may involve geometric changes to slow vehicles down, additional high visibility signage, or auxiliary devices to bring attention to the all-way stop controlled intersection.

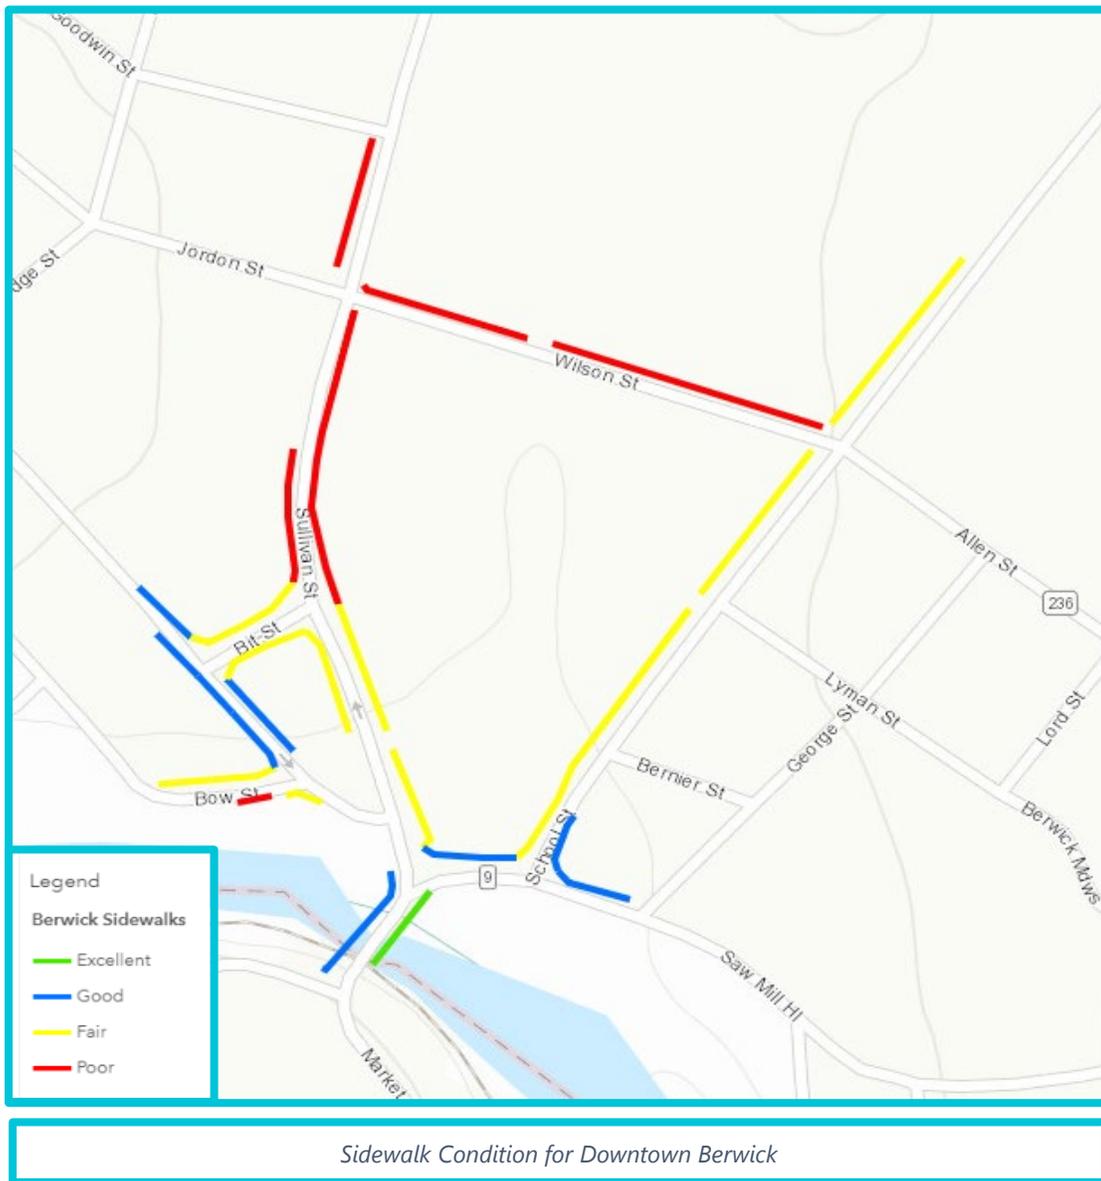
The results of this systematic inventory showed that the vast majority of sidewalks in the downtown Berwick study area are made of pavement, the exceptions being the one on the bridge that connects to Somersworth, NH on Market Street. These sidewalks were rated Excellent and Good (the deficiencies of the 'Good' sidewalk were early signs of wear, cracking, and minor rises in pavement level). These higher rated locations were also the only sidewalk facilities which appeared to be ADA compliant, with all other sidewalks missing some component of a detectable

warning field, correct use of pedestrian buttons at signalized intersection, or in otherwise poor condition for use for all types of users. Generally, the sidewalk condition deteriorated the farther they were located from the bridge.

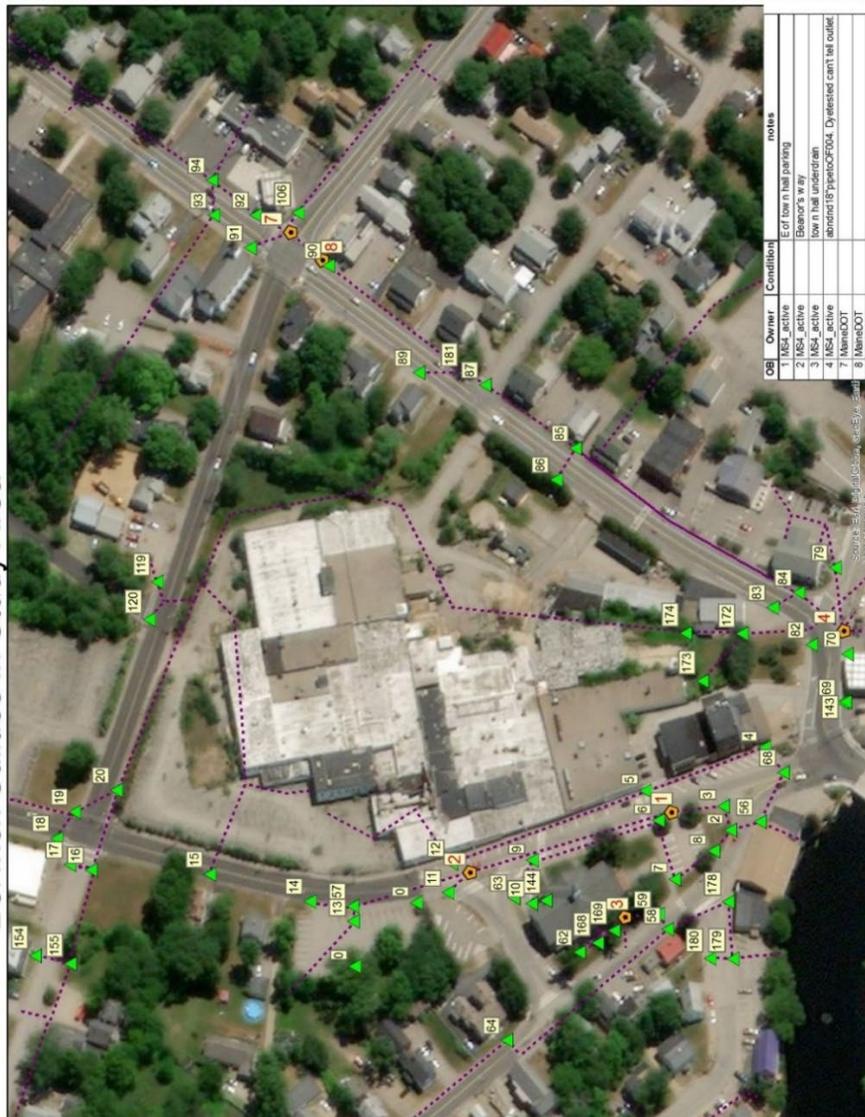
Berwick Utilities in Study Area

MMI was tasked with determining the conditions of the utilities in the study area, including water, sewer, and the stormwater infrastructure. MMI used GIS records and conversations to conclude that there are no major issues with the infrastructure, and that future needs are being planned for by the respective districts or public works. The town of Berwick has an ongoing plan for upgrading its stormwater facilities in an MS4 plan. Discussions held with the Water and Sewer districts did not yield any significant issues, expansions, or concerns with their infrastructure.

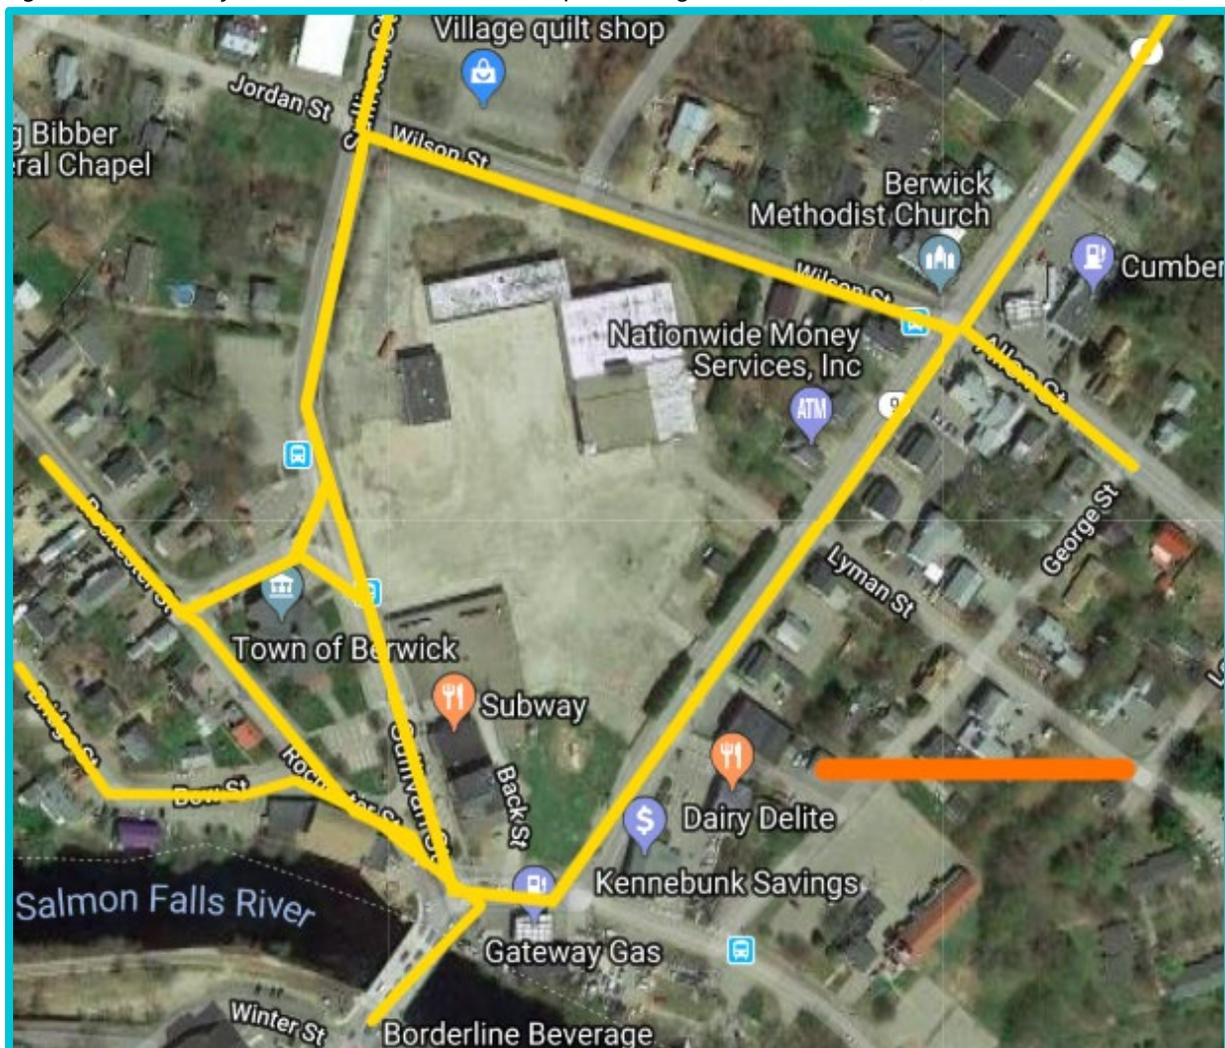
Figure 1. Streets in yellow are evaluated in this report, orange line indicates 400 feet

This report evaluates existing bicycling conditions on the streets surrounding the old tannery in the town of Berwick (see Figure 1). These conditions included both “shared lane” situations, as well as striped shoulder situations. No dedicated bicycle facilities currently exist in the study area.

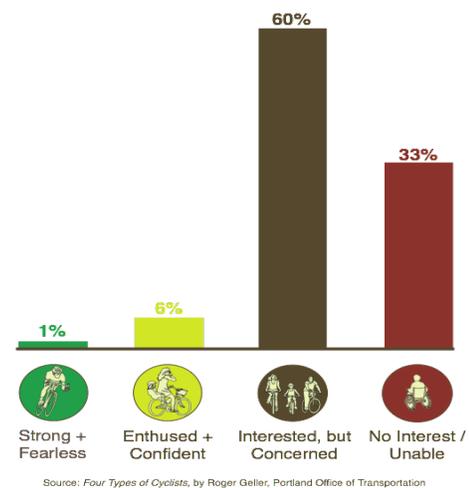
Figure 2: The Geller Typology of Bicycle Riders

Geller's typology breaks a community's population into four types of bicycle riders: *Strong and Fearless*; *Enthused and Confident*; *Interested but Concerned*; and *No How, No Way*. (see Figure 2).

Interested but Concerned riders are average people: parents, kids, seniors and other people who would be willing to ride more if the roadway conditions were more encouraging and safer. Such a rider is likely to be influenced by the presence (or absence) of bicycle facilities that provide guidance or separation from traffic. The *Interested but Concerned* rider is the type of rider whose experience should be considered when assessing--or designing--bicycle facilities. *Interested but Concerned* riders are the group this evaluation of Berwick conditions has in mind.

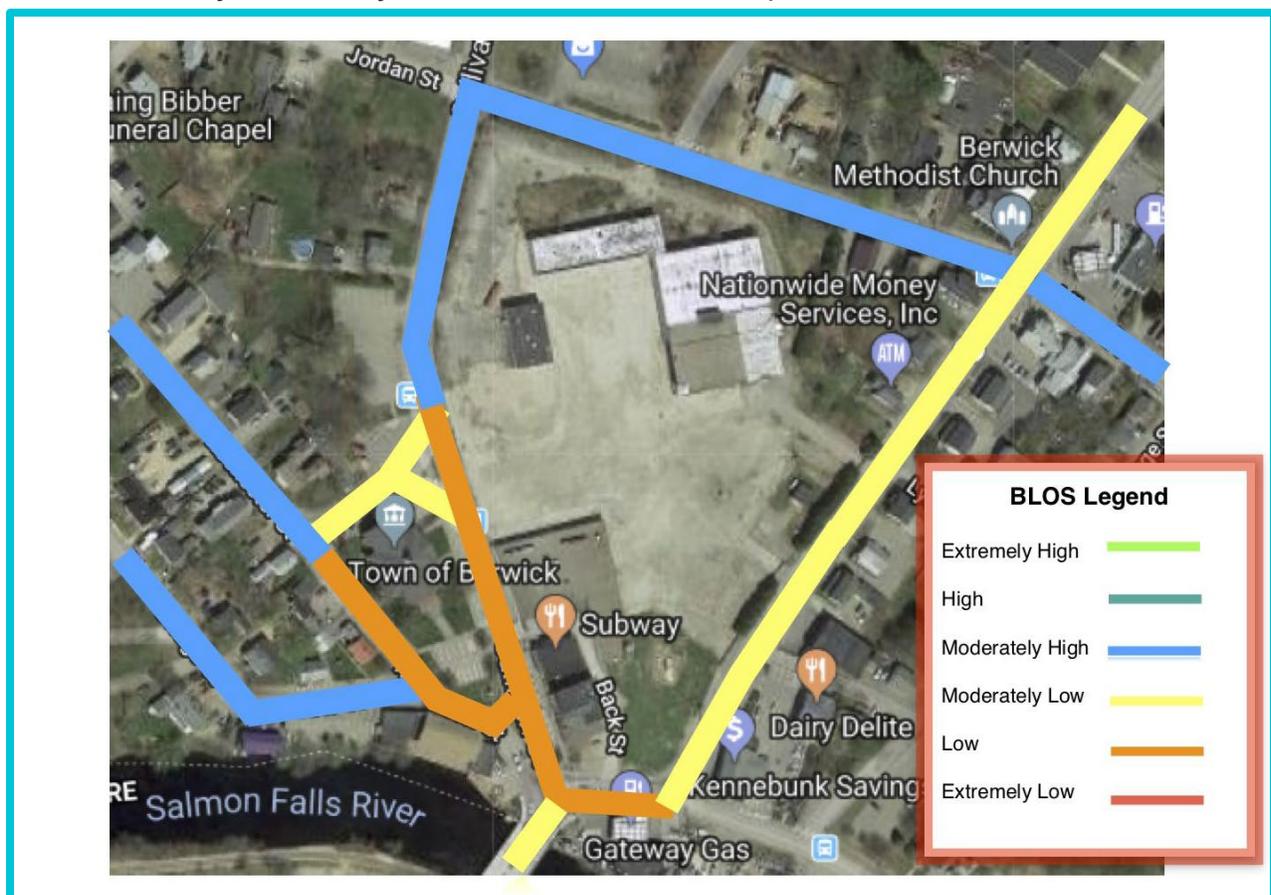
Berwick Study Area Bicycle Level of Service Map

The average grade for the Bicycle Level of Service (BLOS) for the study area is a D, Moderately-Low, rating. It is generally neither an inviting nor supportive context for bicycle riding.

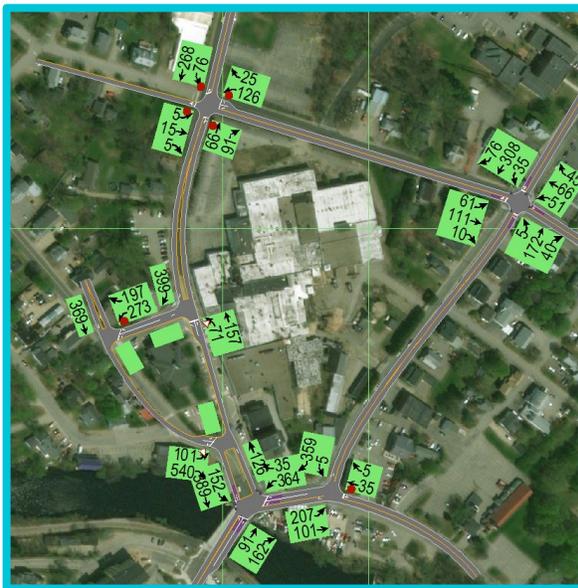
Study area AM Traffic Volumes brought to 2018

For the two signalized intersections in the study area, School Street at Wilson Street and Sullivan Street at Market Street, the signal timing data was collected on September 14th, 2018 which was programmed into the traffic model. The projected 2018 volumes are shown in the graphic below for the AM and PM peak hours.

In order to determine existing traffic delays in the downtown Berwick area, a traffic model utilizing *Synchro* and *SimTraffic* software was created. The traffic volumes utilized were taken from the 2015 report by VHB, *Berwick Traffic Circulation and Parking*. To calibrate the model from model year 2015 to 2018, the traffic volumes were increased to match expected traffic growth recommended by MaineDOT. The MaineDOT area transportation models advise an increase of 0.5% traffic volume growth per year, which in our case would be an increase of 1.5% total.

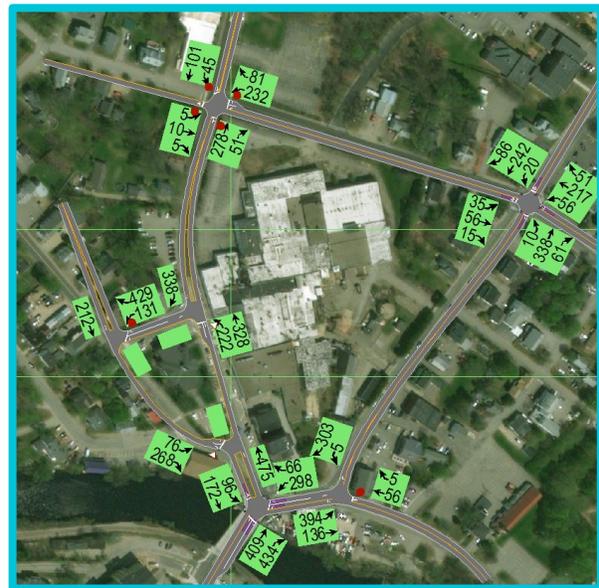
Study area PM Traffic Volumes brought to 2018

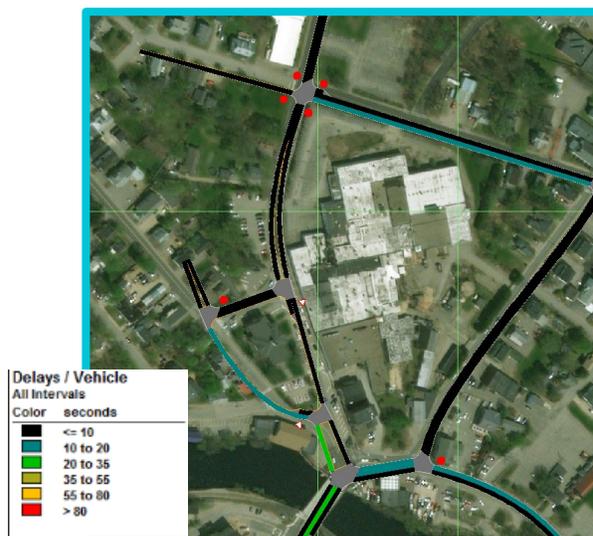
Study area existing AM vehicle delay

The micro-simulation software model was then used to determine existing traffic delays. The resulting modeled traffic delay, shown below in table form, was minimal. Observations during site visits to the study area confirmed the apparent delays. While there was a clear difference in vehicle delay and queuing during peak hour traffic times in the AM and PM, the intersections were able to process vehicles smoothly at both the signalized and unsignalized intersections.

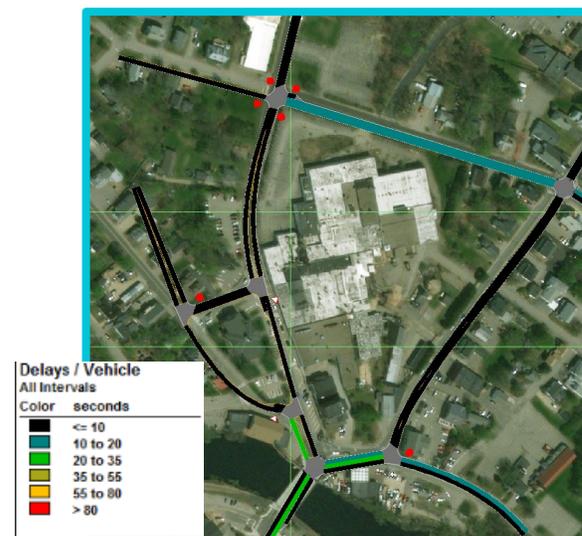
Study area existing PM vehicle delay

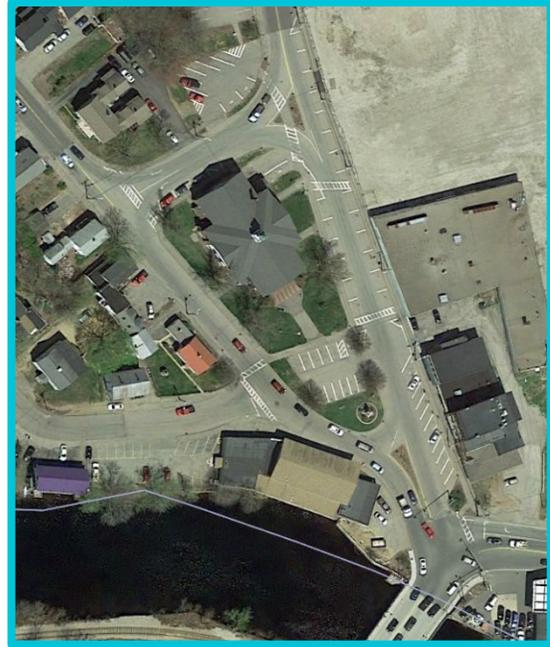
Berwick Sub-Area, where the majority of substantial concept alternatives differ.

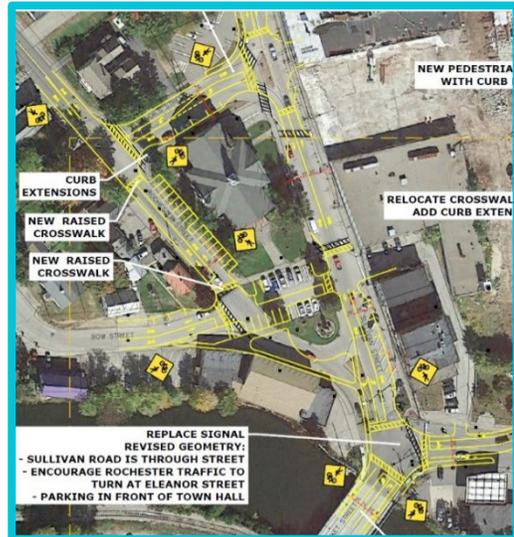
Concept 2 – Rochester Street (1) – Instead of both Sullivan Street and Rochester Street converging as separate streets into the signalized intersection with Saw Mill Hill, Rochester Street becomes the only southbound approach. Sullivan Street abuts into Rochester Street southeast of Bow Street, and left turns are prohibited from Rochester Street to Sullivan Street. The area above Saw Mill Hill, currently open space and an off-street parking lot, will be converted to additional off-street parking with a driveway entrance opposite of the new intersection with Saw Mill Hill. It is assumed that traffic will shift away from Sullivan Street and onto Rochester Street in the area.

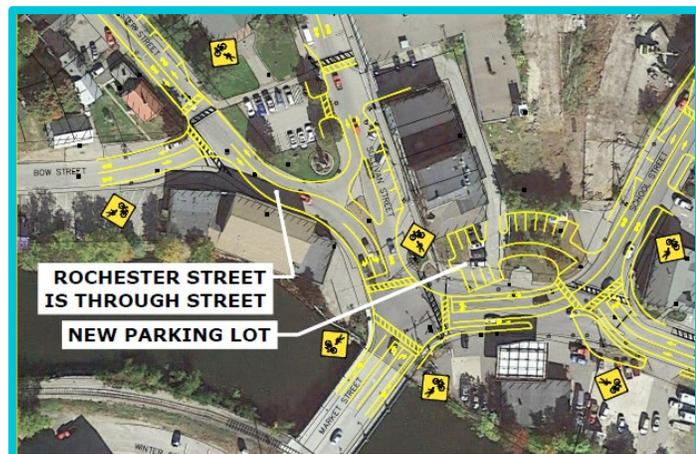
Concept 3 – Rochester Street (2) – Similar to Concept 2, Concept 3 differs in that it allows left turns from Rochester Street to Sullivan Street at their intersection above the signalized intersection of Sullivan Street with Saw Mill Hill, but does not add certain on-street and off-street parking for the downtown.

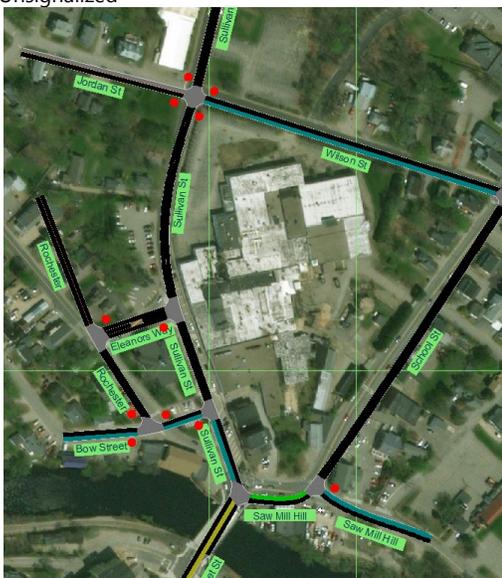
Concept 1 – Future AM

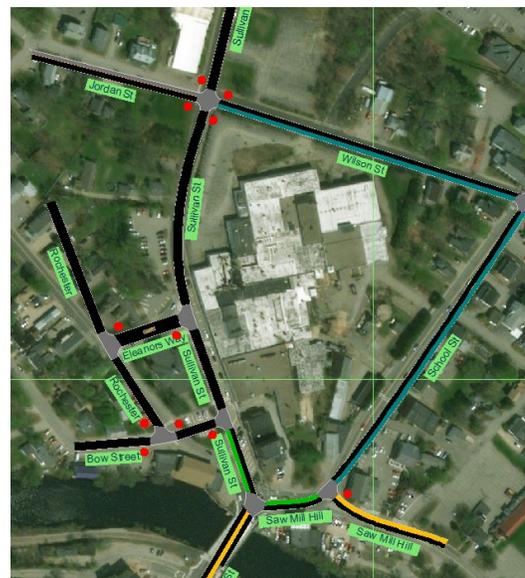
Concept 1 – Future PM

Future PM – Concept 1		
Intersection	Overall Delay (s)	LOS
Market/Rochester/Saw Mill Hill	27.9	C
School/Wilson/Allen	12.6	B
Sullivan/Wilson/Jordan*	10.0	B
School/Saw Mill Hill*	5.3	A
Rochester/Bow*	3.7	A

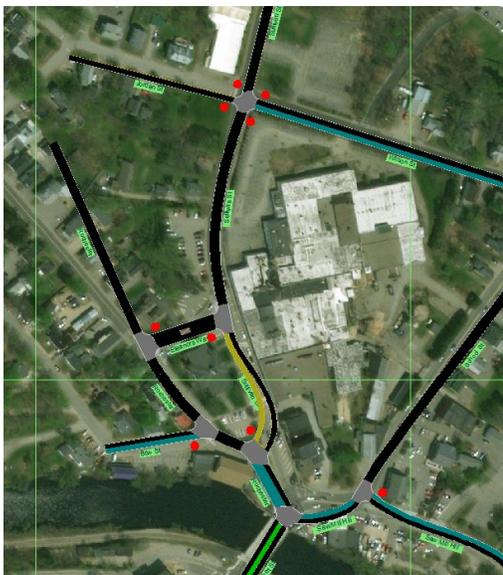
Concept 2 – Future AM

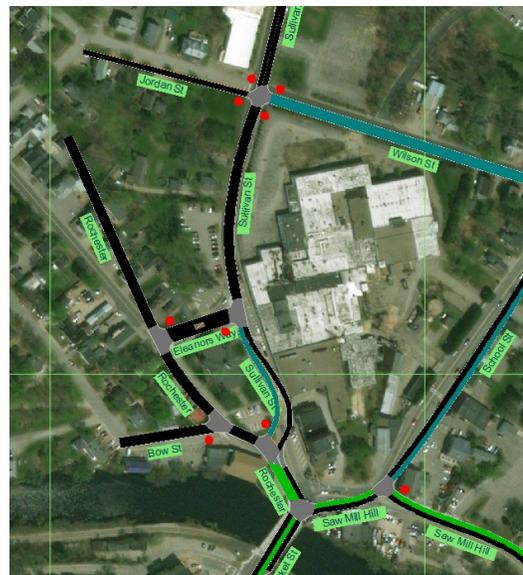
Concept 2 – Future PM

Future PM – Concept 2		
Intersection	Overall Delay (s)	LOS
Market/Rochester/Saw Mill Hill	20.2	C
School/Wilson/Allen	14.3	B
Sullivan/Wilson/Jordan*	9.4	A
School/Saw Mill Hill*	4.1	A
Rochester/Sullivan*	4.2	A

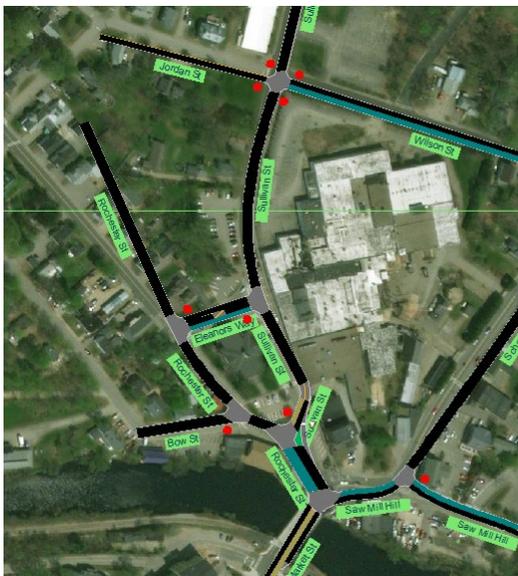
Concept 3 – Future AM

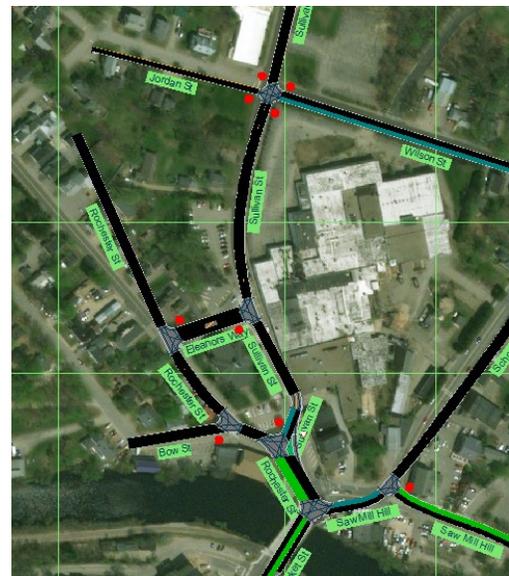
Concept 3 – Future PM

Future PM – Concept 3		
Intersection	Overall Delay (s)	LOS
Market/Rochester/Saw Mill Hill	20.0	C
School/Wilson/Allen	13.5	B
Sullivan/Wilson/Jordan*	9.4	A
School/Saw Mill Hill*	8.1	A
Rochester/Sullivan	3.0	A

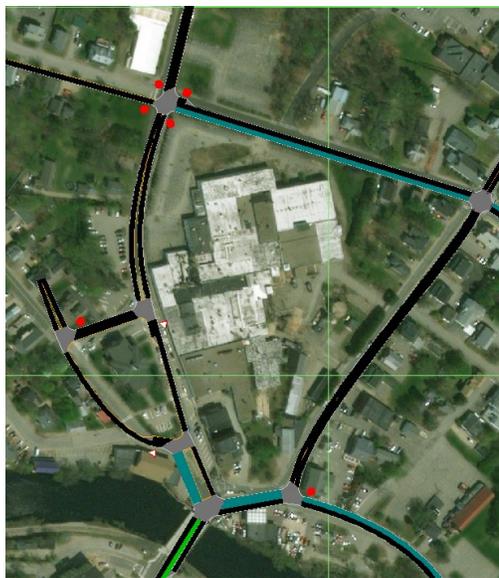
No Build – Future AM

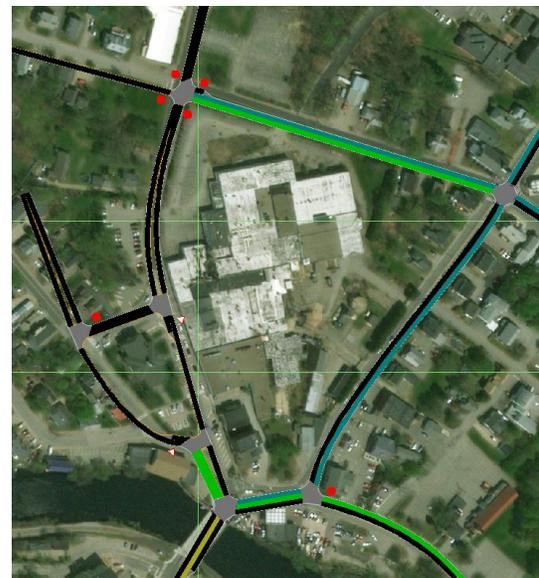
No Build – Future PM

Future PM – No Build		
Intersection	Overall Delay (s)	LOS
Market/Sullivan/Saw Mill Hill	23.4	C
School/Wilson/Allen	14.3	B
Sullivan/Wilson/Jordan*	9.8	A
School/Saw Mill Hill*	3.0	A

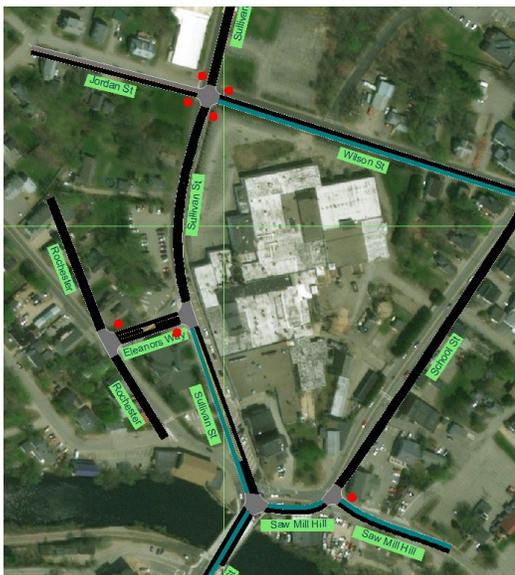
Concept 1A – Future AM

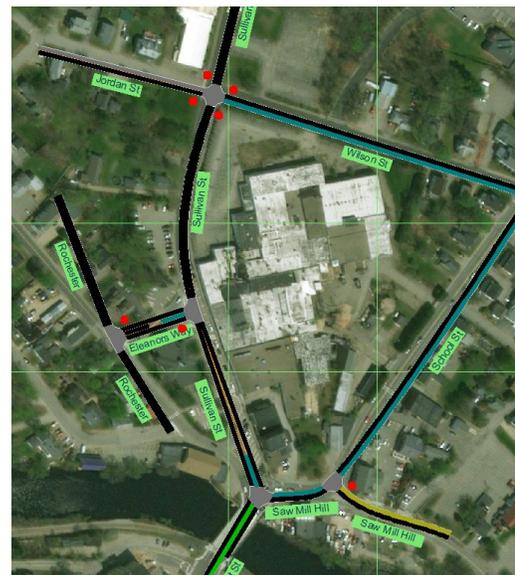
Concept 1A – Future PM

Future PM – Concept 1A		
Intersection	Overall Delay (s)	LOS
Market/Rochester/Saw Mill Hill	15.5	B
School/Wilson/Allen	13.6	B
Sullivan/Wilson/Jordan*	10.3	B
School/Saw Mill Hill*	3.3	A
Sullivan/Eleanor	5.0	A

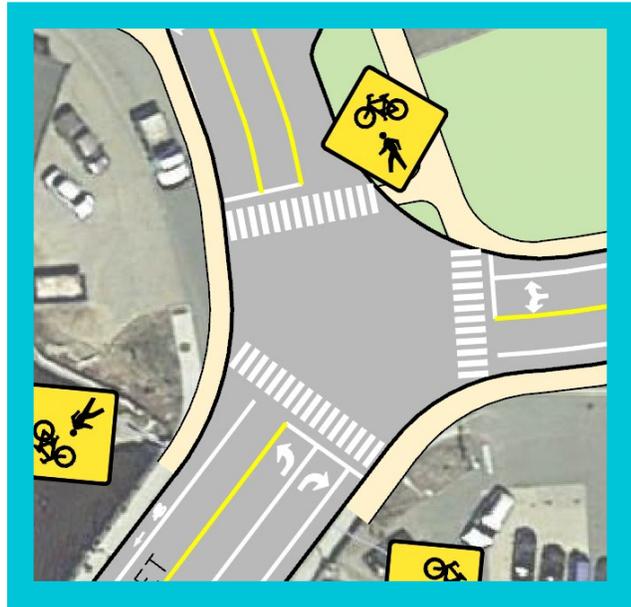
Rochester Street/Saw Mill Hill/Sullivan Street

Improvements include a removal of the westbound right turn lane, which then converts the existing left turn lane into a left and right turn lane. The extra space taken from the right turn lane will allow additional greenspace at the intersection. A crosswalk is added to the northside of the intersection across Sullivan Street. A diagonal parking space closest to the intersection is removed on Sullivan Street to allow safer backouts for vehicles. The approach lanes have been narrowed to discourage higher vehicle speeds. Bicycle lanes have been continued from Somersworth. ADA improvements would be made where necessary.

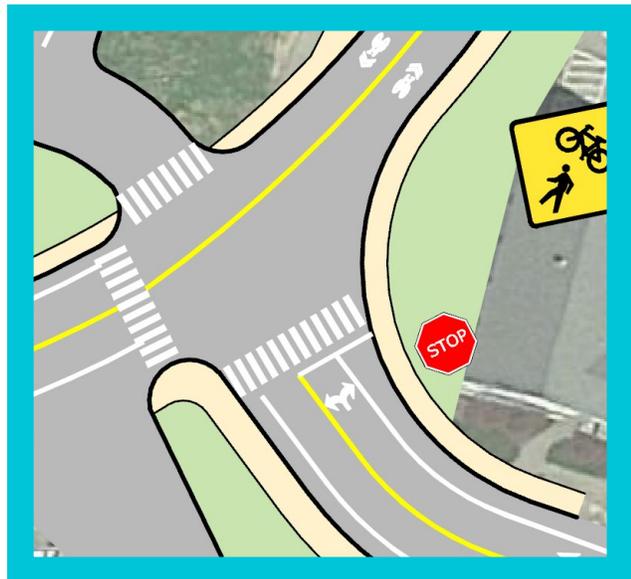
Saw Mill Hill/School Street

Improvements include a total geometric reconfiguration of the intersection. Saw Mill Hill is brought to a "T" at the intersection with School Street. This will allow a safer crossing with vehicles approaching School Street at 90 degrees. The crosswalks will all be a shorter crossing distance. Bicycle lanes from Somersworth terminate at this intersection where shared lane markings begin. The approach lanes have been narrowed to discourage higher vehicle speeds. Back Street, with additional parking, has been moved to be opposite of Saw Mill Hill for safety. ADA improvements would be made where necessary.

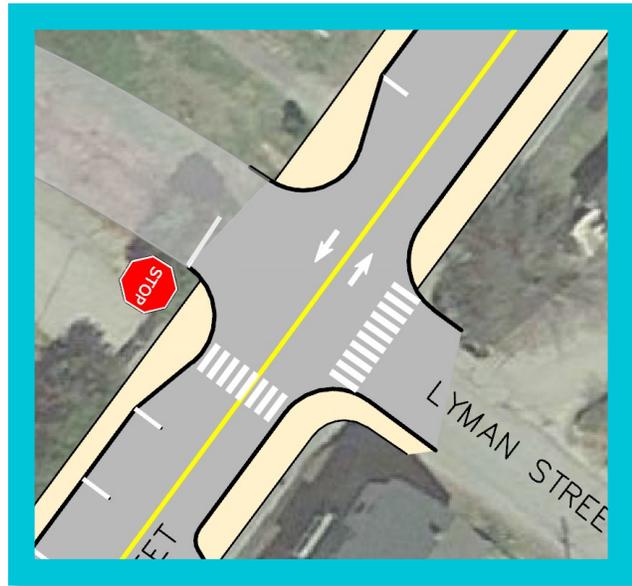
School Street/Lyman Street

Improvements include a new crosswalk and curb extensions (aka pedestrian bump-outs), to decrease the crossing distance on School Street. The intersection has been reconfigured to provide access to a future internal road on the former Prime Tanning parcel. Parking spaces are eliminated in the immediate vicinity to further increase the sight distance for pedestrians. Shared lane markings have been added for bicycles. ADA improvements would be made where necessary.

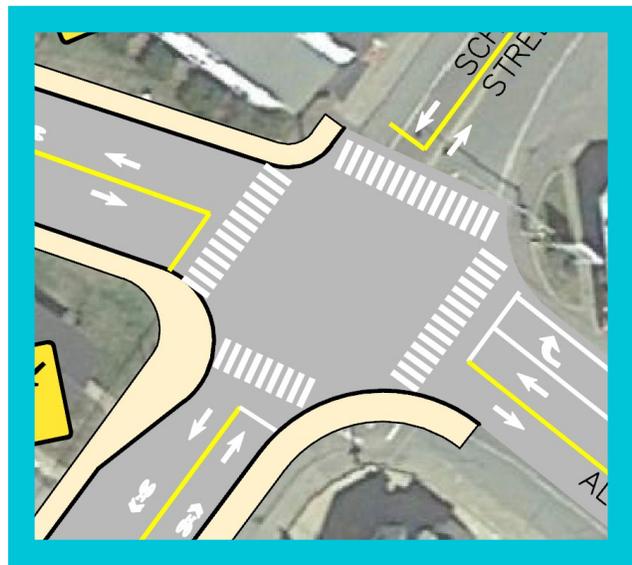
School Street/Wilson Street Allen Street (MaineDOT designated High Crash Location)

Improvements include the replacement of the traffic signal hardware. The traffic controller and other traffic signal equipment is old and does not run optimally. Other improvements include curb extensions to reduce pedestrian crossing distances for safety. Due to the intersection being designated a High Crash Location from MaineDOT, additional safety improvements should be considered. For bicycles, shared lane markings have been added. ADA improvements would be made where necessary.

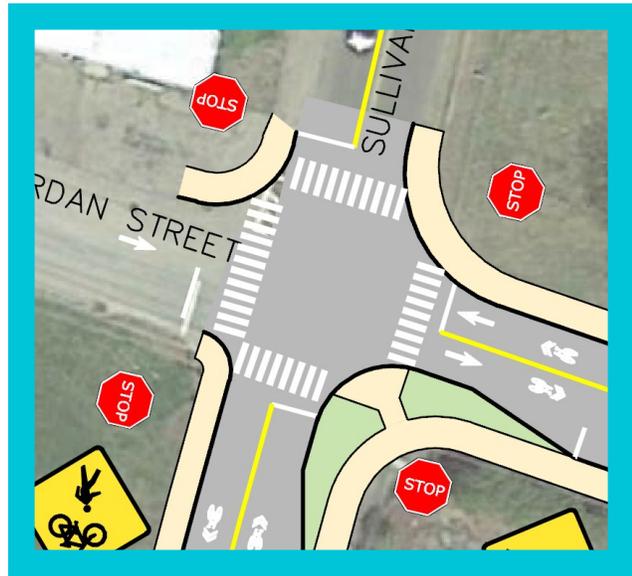
Wilson Street/ Sullivan Street/Jordan Street

Improvements include adding curb extensions to reduce the crossing distance for pedestrians to improve safety. Also proposed is a landing area for pedestrian crossing to and from the northwest corner of the intersection which is currently at grade with the road. Sidewalks would be continued through the area. Shared lane markings have been added for bicycles. ADA improvements would be made where necessary.

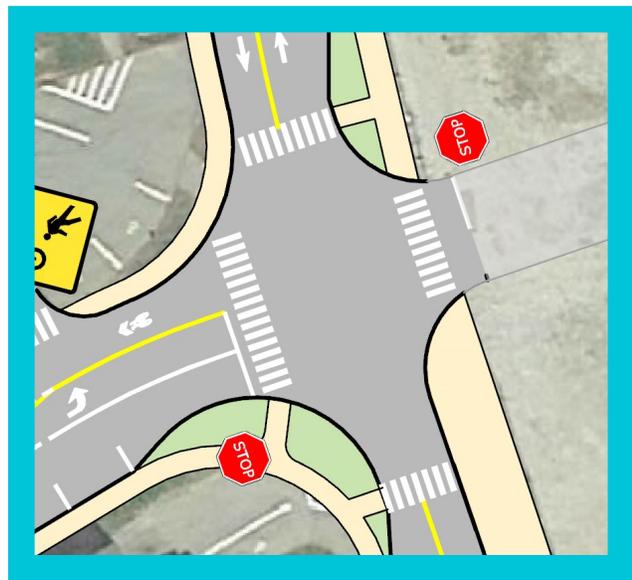
Sullivan Street/Eleanor's Street

Improvements include a new crosswalk and curb extensions. The intersection has been reconfigured to provide access to a future internal road on the former Prime Tanning parcel. Parking spaces are eliminated in the immediate vicinity to further increase the sight distance for pedestrians. The intersection now allows for 2-way vehicle travel on both Eleanor Street and Sullivan Street below Eleanor Street. A handicapped accessible parking spot has been designated for the nearest on-street parking stall. This intersection may be signalized with any significant development in the former Prime Tanning parcel. Shared lane markings have been added for bicycles. ADA improvements would be made where necessary.

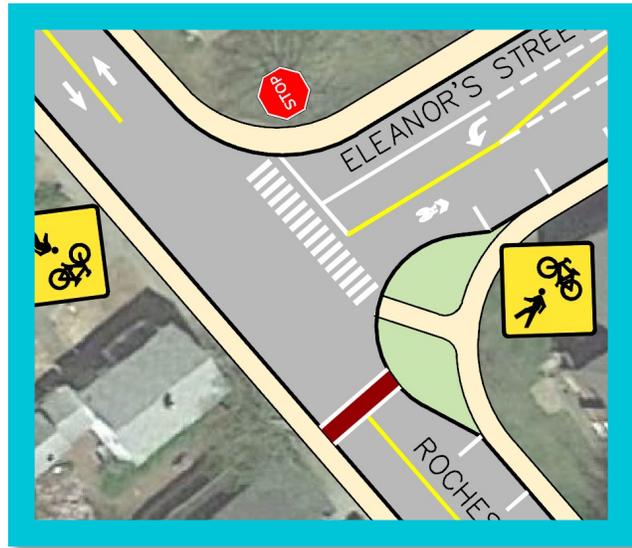
Rochester Street/Eleanor's Street

Improvements include curb extensions and a raised crosswalk. The raised crosswalk should discourage higher vehicle speeds. Vehicle travel is now 2-way on both Eleanor's Street and Rochester Street below Eleanor's Street. Shared lane markings have been added for bicycles. ADA improvements would be made where necessary.

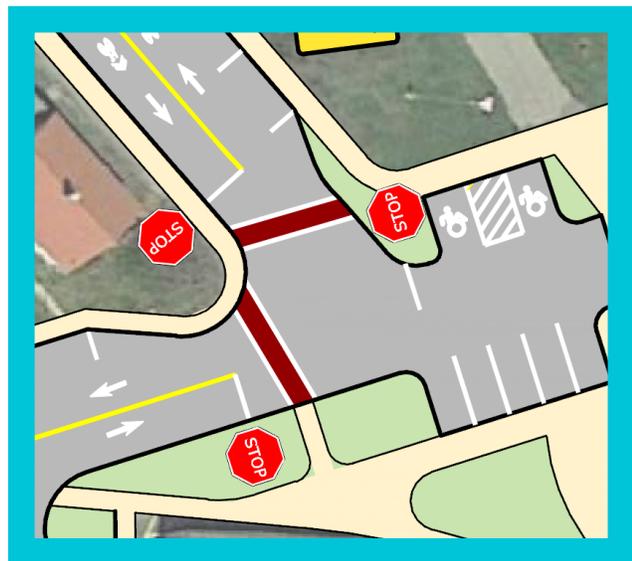
Rochester Street/Bow Street

Improvements include curb extensions and a raised crosswalk. The raised crosswalk for the Bow Street and Rochester Street approaches should discourage higher vehicle speeds. Access to the parking lot is now made from Rochester Street instead of Sullivan Street. Shared lane markings have been added for bicycles. ADA improvements would be made where necessary.

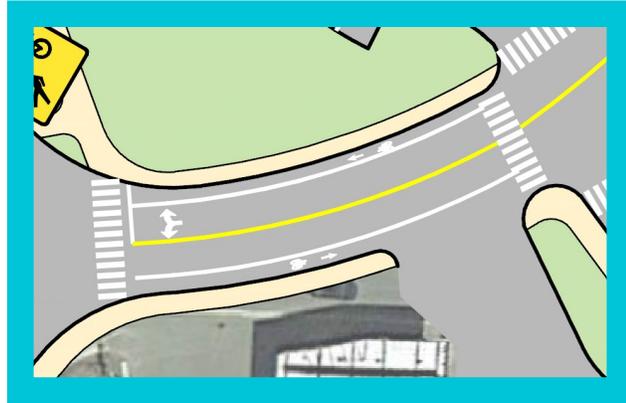
Saw Mill Hill – Sullivan Street to School Street

Improvements include the removal of the westbound right turn lane, which will allow for additional greenspace, a bike lane, and pedestrian amenities without adding significant vehicle delay. The lanes are marked at 11-feet wide which should discourage higher vehicle speeds. The road has been realigned to the north to be consistent with the proposed improvements at the School Street/Saw Mill Hill intersection. ADA improvements would be made where necessary.

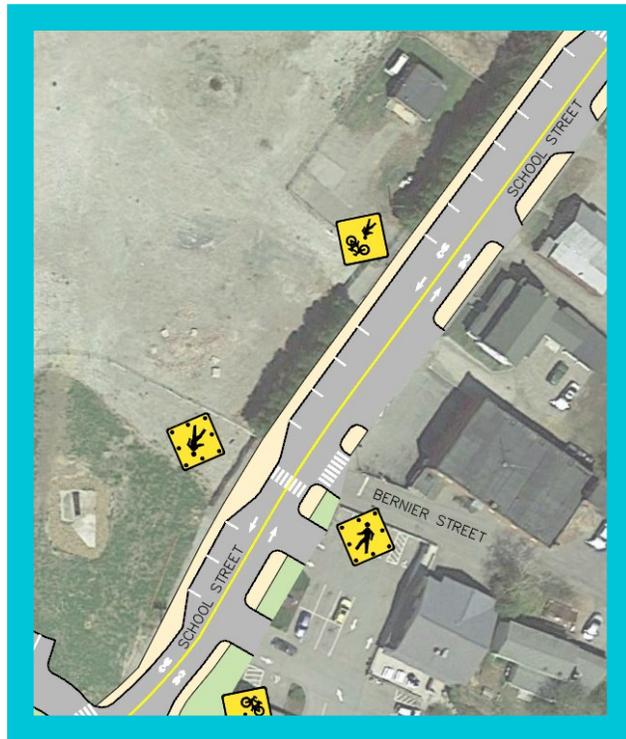
School Street – Saw Mill Hill to Lyman Street

Improvements include narrowing of the lanes to 11 feet and delineating the parking on the west side of the road. Gaps in the sidewalk are filled. A crosswalk with a rectangular-rapid-flashing-beacon (RRFB) is proposed at Bernier Street. For bicycles, shared lane markings have been added. While not in the proposed improvements, MMI has identified areas near the bank and fire station where curb cuts could be eliminated to increase safety for all users. Removing access at the fire station would be contingent on whether the department was moved to a new location. ADA improvements would be made where necessary.

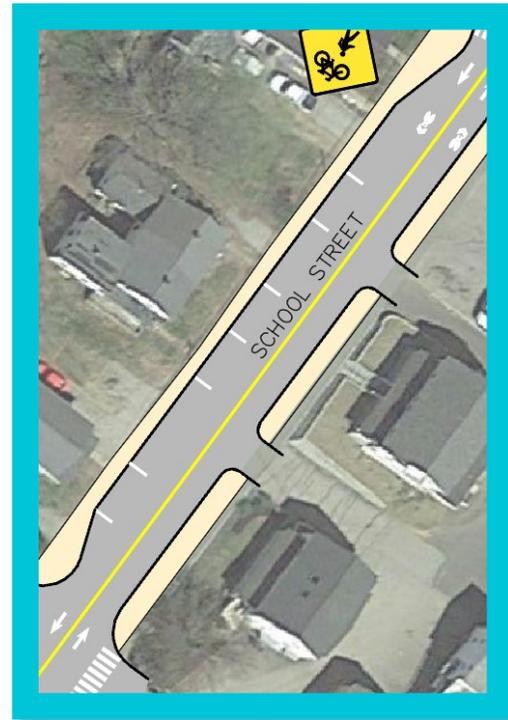
School Street – Lyman Street to Wilson Street

Improvements include narrowing of the lanes to 11 feet and delineating the parking on the west side of the road. Gaps in the sidewalk are filled on the northeast side of the section. Shared lane markings have been added for bicycles. ADA improvements would be made where necessary.

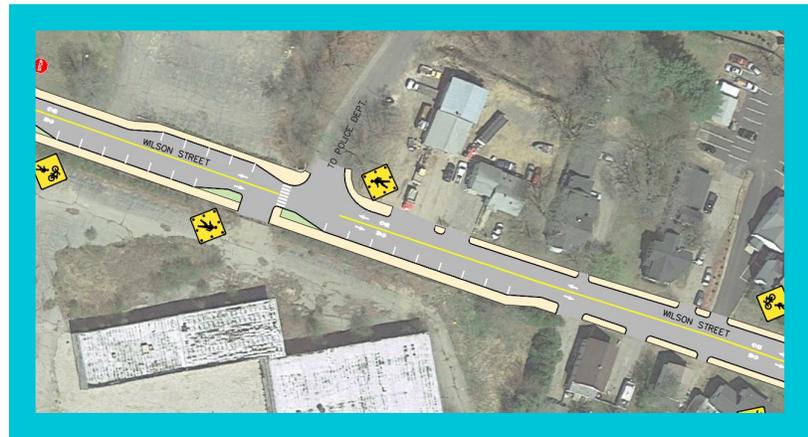
Wilson Street – Sullivan Street to School Street

Improvements include narrowing of the lanes to 11 feet and delineating the parking on each side of the road. A crosswalk with a rectangular-rapid-flashing-beacon (RRFB) is proposed at the driveway to the Police Station. Curb extensions were also added at the crosswalk to reduce pedestrian walking distances. Shared lane markings have been added for bicycles. ADA improvements would be made where necessary.

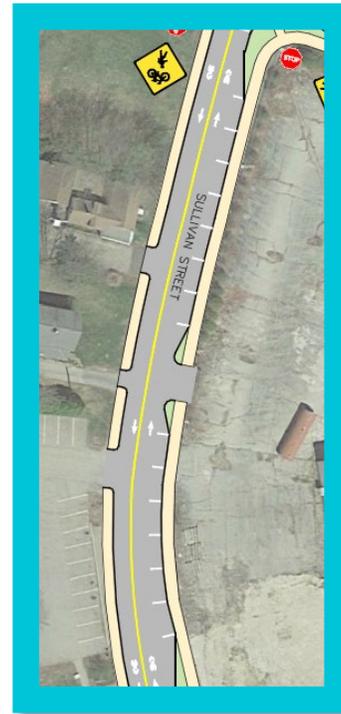
Sullivan Street – Wilson Street to Eleanor’s Street

Improvements include narrowing of the lanes to 11 feet and delineating the parking on the east side of the road. Gaps in the sidewalk are filled on the west side of this section. For bicycles, shared lane markings have been added. Curb extensions have been added at the driveway to the central parcel. ADA improvements would be made where necessary.

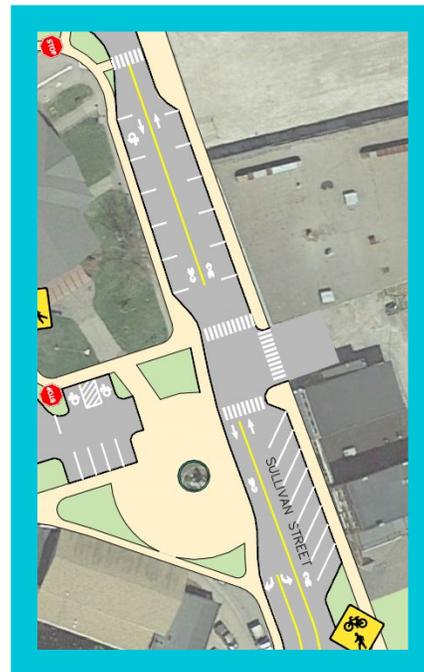
Sullivan Street – Market Street to Eleanor’s Street

Improvements include narrowing of the lanes to 11 feet and curb extensions at Back Street, to reduce the distance of pedestrians crossing the street. Two-way parking has been reintroduced. Diagonal parking has been retained near Saw Mill Hill. This was not the MMI’s first choice, which preferred parallel parking and the addition of a much wider sidewalk. For bicycles, shared lane markings have been added. ADA improvements would be made where necessary.

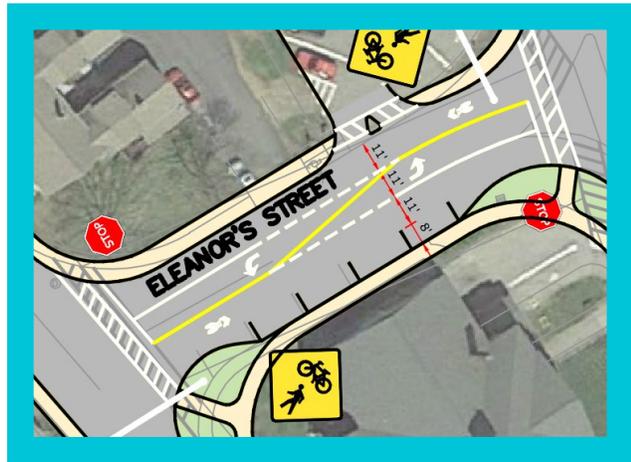
Eleanor's Street – Rochester Street to Sullivan Street

Improvements include narrowing of the lanes to 11 feet and allowing 2-way traffic. Left turn lanes have been added to facilitate vehicle movements for the increase in traffic from the termination of Rochester Street. For bicycles, shared lane markings have been added. ADA improvements would be made where necessary.

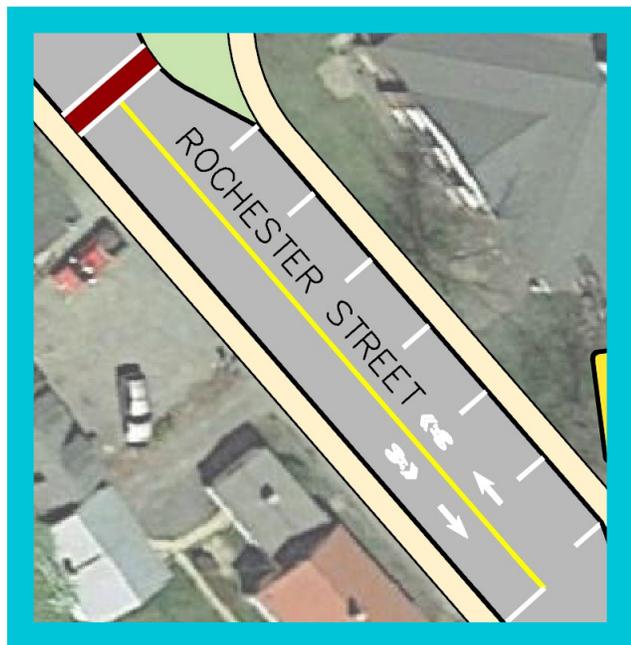
Rochester Street – Eleanor's Street to Bow Street

Improvements include narrowing of the lanes to 12 feet and allowing 2-way traffic. Rochester Street is essentially dead-ended at Bow Street, forcing through traffic to turn on to Eleanor's Street. Parallel parking spaces have been added to the east side of the road, but MMI created these as an offset to parking spaces lost elsewhere in the vicinity. The preference would be to eliminate the parking, add narrow shoulders, and increase the size of the sidewalk. For bicycles, shared lane markings have been added. ADA improvements would be made where necessary.

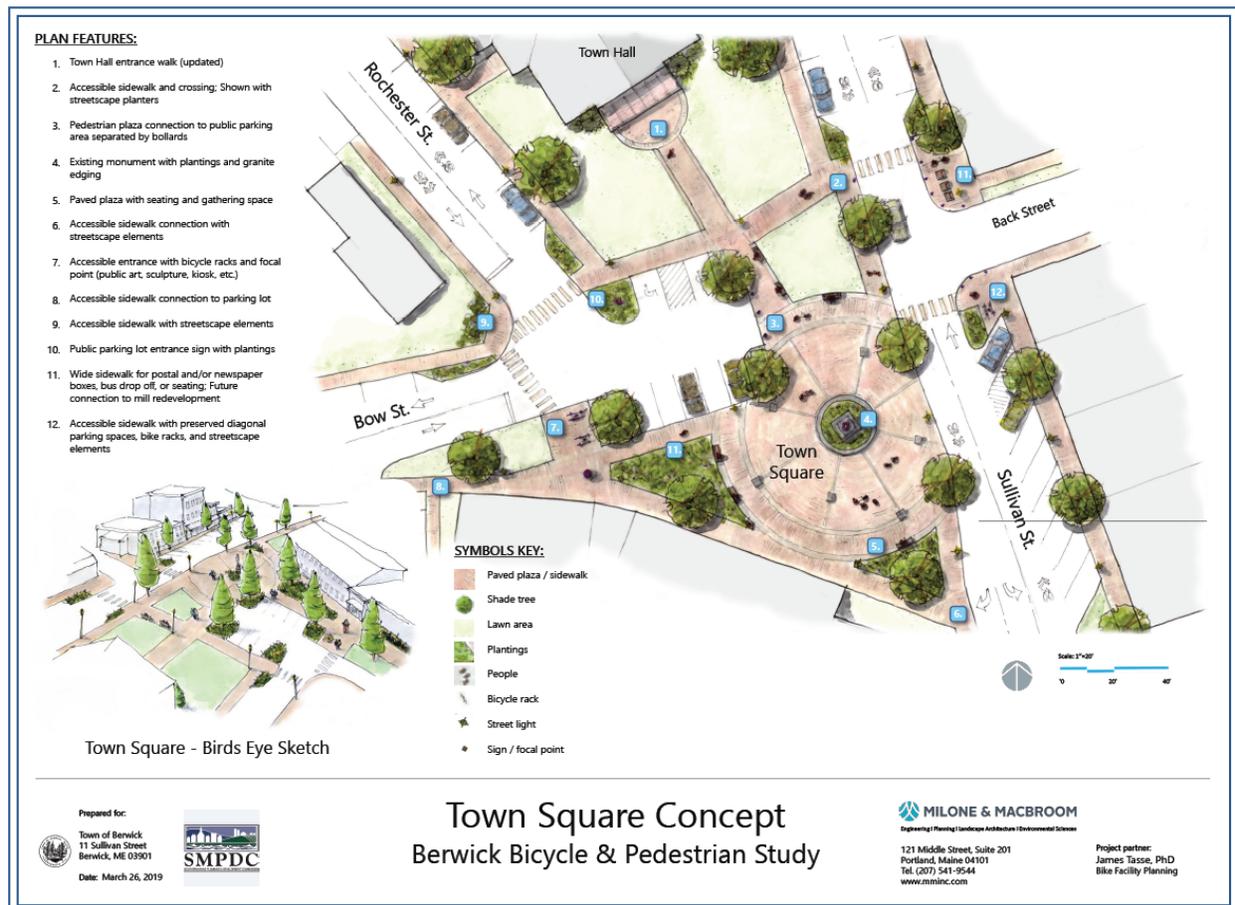
Pedestrian Plaza

A pedestrian plaza is proposed for the area surrounding the Civil War monument south of the Berwick Town Hall. The area would be a mix of pavers, grass, and hardscaping. Trees would also be added in certain locations. The Parking lot has been retained, but MMI left this as an offset to parking spaces lost elsewhere in the vicinity. The preference would be to eliminate the parking, and increase the plaza area for continuity, preserving a space in the downtown free from vehicle conflicts and allowing town community events.

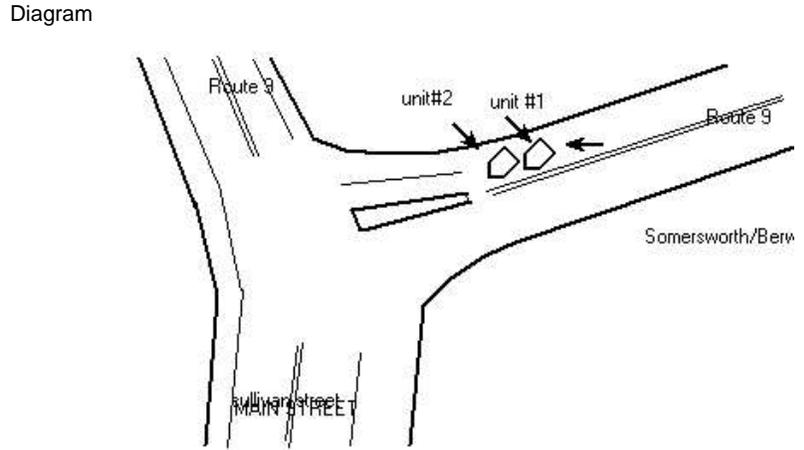
Narrative
Unit #1 was traveling east on Route 9 on the Somersworth/Berwick bridge when it attempted to stop at the stop light. Due to ice on the road, Unit #1 could not stop in time and struck Unit #2 from the rear. Unit #2 was sitting at the stop light waiting to make a left hand turn.

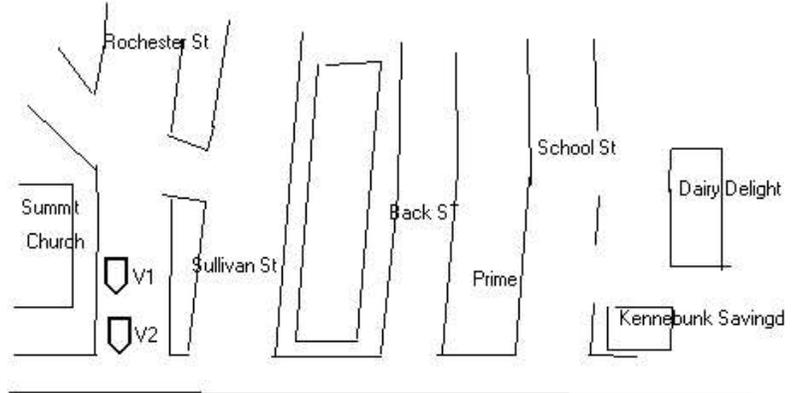
Diagram

Operator of V1 was looking at the radio and thought the light had changed. He accelerated and struck the rear of V2.
