Berwick Downtown Vehicle, Bicycle, and Pedestrian Study

Berwick, Maine
4/30/19

Prepared by:
MILONE & MACBROOM, INC.
121 Middle Street, Suite 201
Portland, Maine 04101
(207) 541-9544
www.mminc.com
with *James Tasse Consulting, LLC*
Bike Facility Planning

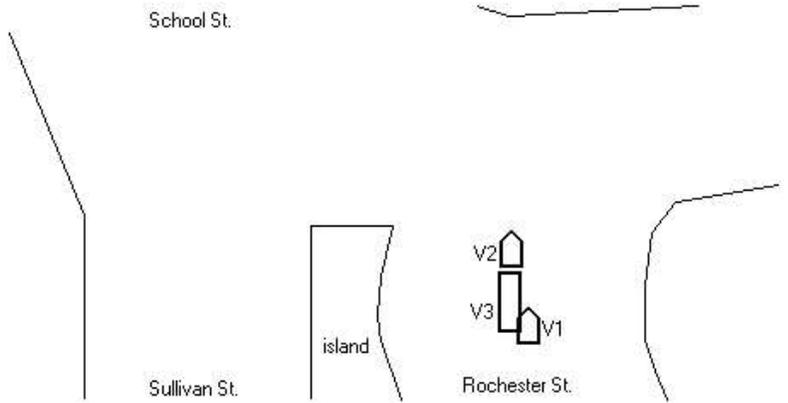
Diagram

V1 was stopped behind V2, which was towing V3, near the intersection of Rochester Street and School Street. As the light turned green V2/V3 began to make a left turn. V1 began to move forward to make a right turn and became pinched between V3 and the curb.

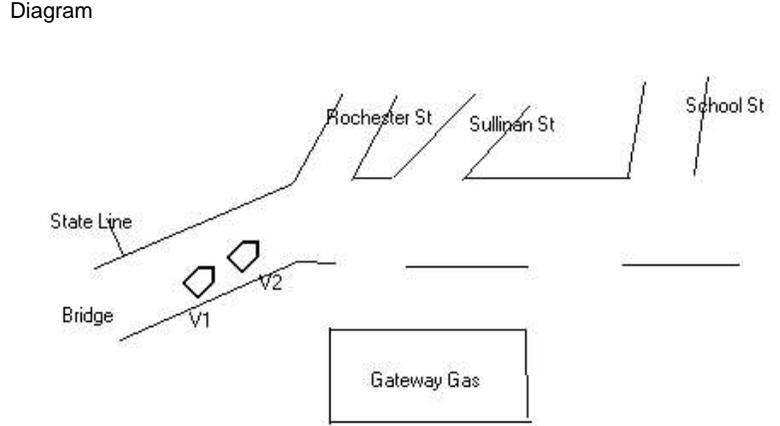
Narrative
V2 was stopped on the bridge at the light. V1 was unable to stop due to ice on the bridge and rear ended V2.

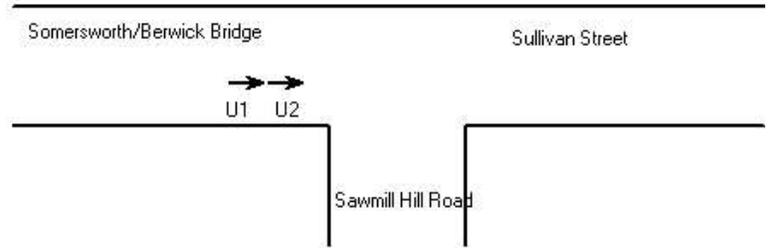
Unit 2 stopped at stop light on Somersworth/Berwick Bridge. Unit 1 struck rear of Unit 2.

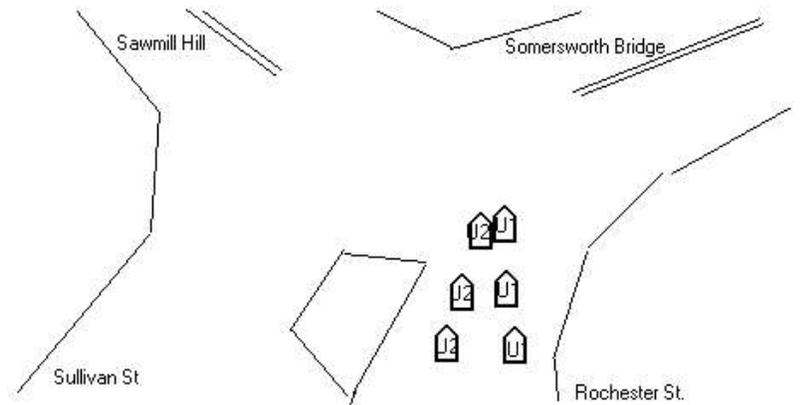
Crash Narrative

U1 and U2 were side by side at the stop light on Rochester St and Sawmill Hill intersection. When the light turned green, U1 and U2 proceeded forward into the intersection. Both vehicles intended on turning in opposite directions, however they both went wide and struck each other as they moved forward about to make each turn.

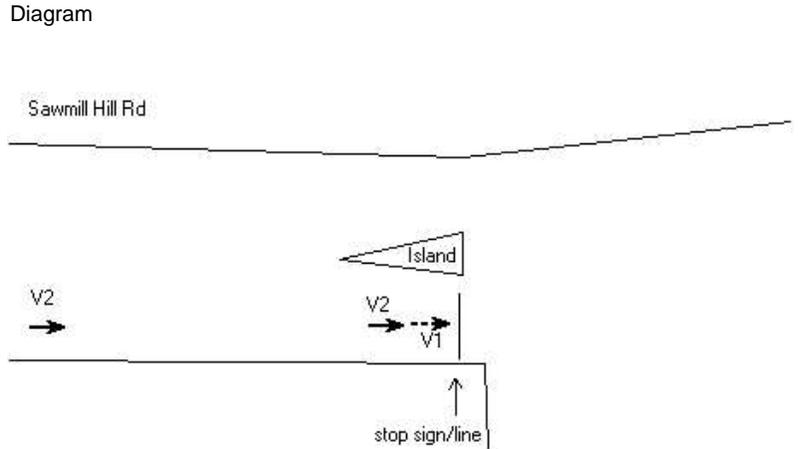
Narrative
V1 was stopped at a stop sign on Sawmill Hill Rd. V2 approached the intersection and failed to stop behind V1 and struck the rear of V1. Operator of V2 stated he was talking to the passenger and did not see V1.

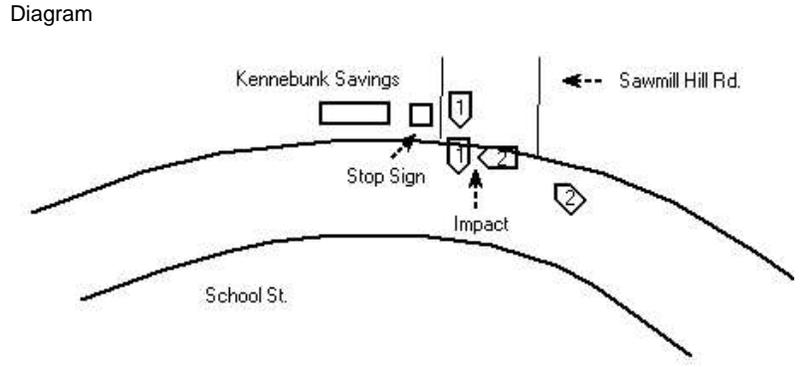
Narrative
U2/OP2 traveling on School St. heading outbound in the area of Gateway Gas.
U1/OP1 traveling inbound on Sawmill Hill Rd.
OP1 failed to stop at stop sign on Sawmill Hill Rd. while entering School St. and making a left turn. OP2 struck OP1 on the driver side of U1.
No Damage to U1. Minor damage to U2 consisting of front bumper cover.
OP1 stated she began to skid when attempting to stop at the stop sign. Road conditions were wet however no snow or ice present. Temperature at approximately 50 degrees. OP2 stated OP1 never stopped.

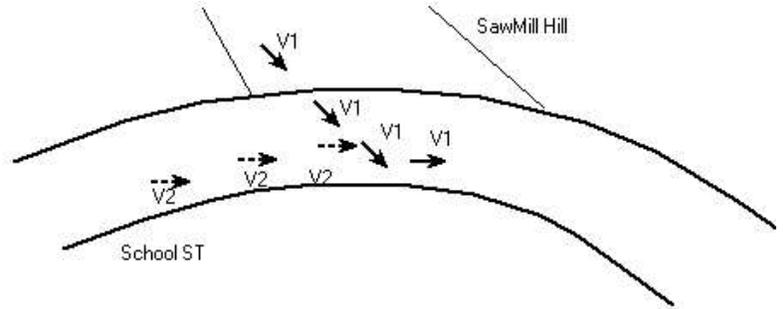
Diagram

V1 came to a complete stop at SawMill Hill and School. V1 failed to see V2 following School ST roadway(south). V1 failed to yield and turned left onto School ST as V2 struck the rear passenger side of V1.

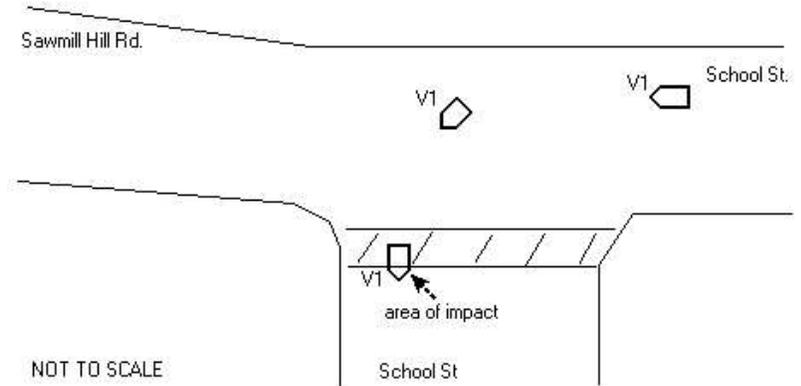
Diagram

V1 was driving east on School Street. V1 struck a pedestrian that was crossing School Street on a marked cross walk.

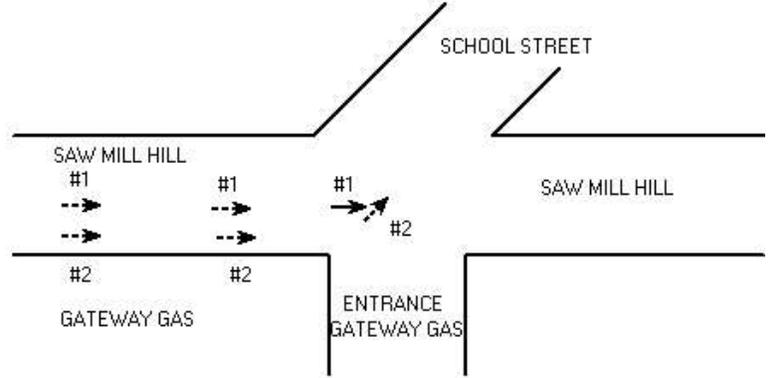
Unit 1 was traveling east on Saw Mill Hill in front of Gateway Gas. Unit 2 overtook Unit 1 on Unit 1's right side. Unit 2 turned left onto School Street in front of Unit 1 who was also turning left onto School Street. Unit 1 and Unit 2 collided. Unit 2 attempted to flee the scene and Unit 1 gave chase with Driver 1 calling 9-1-1. Unit 2's location was lost on Route 236.

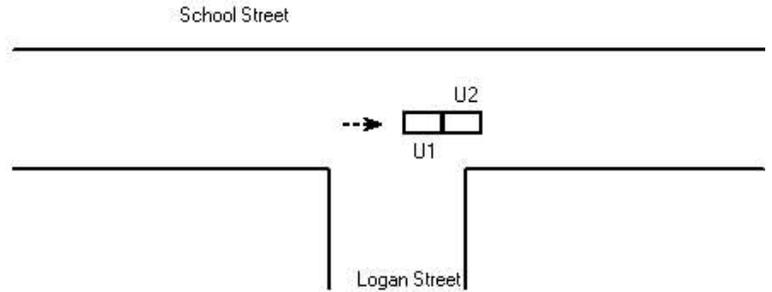
Crash Narrative

U2 AND U1 WERE TRAVELING ON SCHOOL STREET AT THE LOGAN STREET INTERSECTION. U2 SLOWED FOR STOPPED TRAFFIC AND U1 COULD NOT STOP IN TIME, COLLIDING WITH U2.

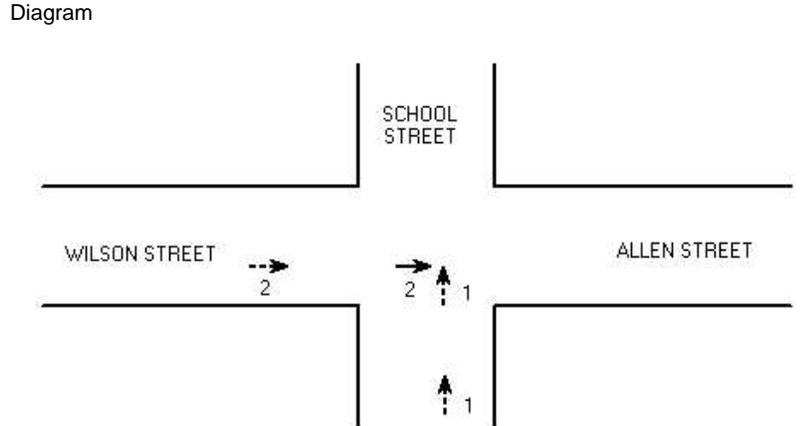
Narrative
Unit 1 ran red light, striking Unit 2.

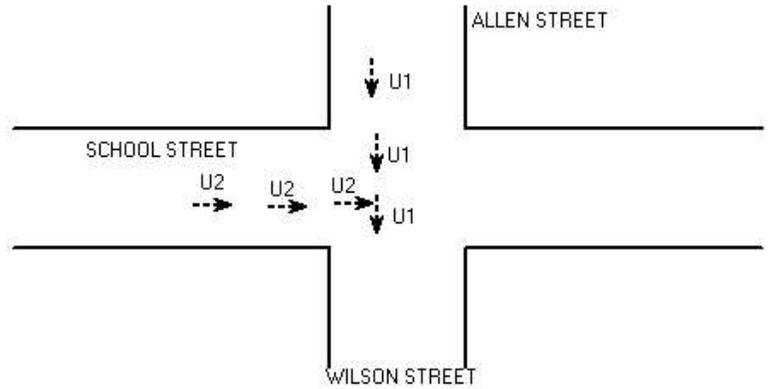
Diagram

U2 COULD NOT STOP IN TIME AND CRASHED INTO THE PASSENGER SIDE DOOR OF U1. OPERATOR 2 STATED U1 DID NOT STOP AT THE TRAFFIC LIGHT.

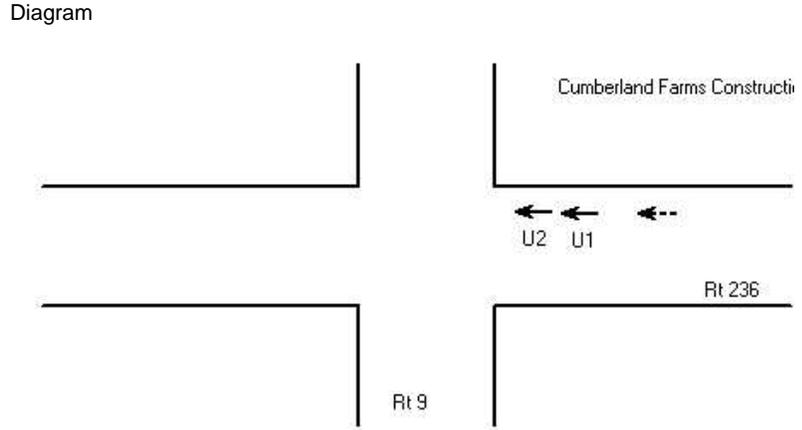
Narrative
Unit 2 was stopped at the traffic light at the intersection of Route 9 and Route 236. Unit 1 struck Unit 2 in the rear, causing damage to the rear bumper.
Unit 1 fled the scene.
Witness followed unit 1 to a driveway on Sidney Drive. OP of Unit 1 ran from police. K9 search conducted with negative results. OP of Unit 1 turned himself into police a couple hours later.
OP charged with OAS and Leaving the Scene of a Property Damage Accident. He was also arrested on two outstanding warrants. Unit 1 uninsured.

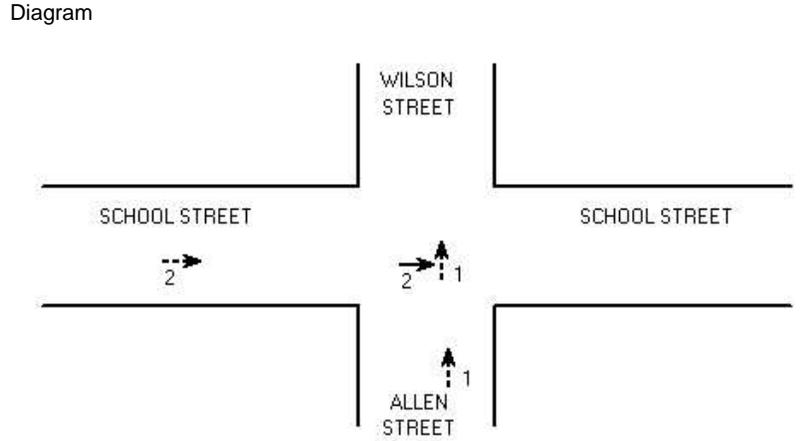
Narrative
 Unit 1 was traveling on Wilson Street from Allen Street when Unit 2 ran a red light and struck Unit 1.
 Driver 2 stated he did not see the light.

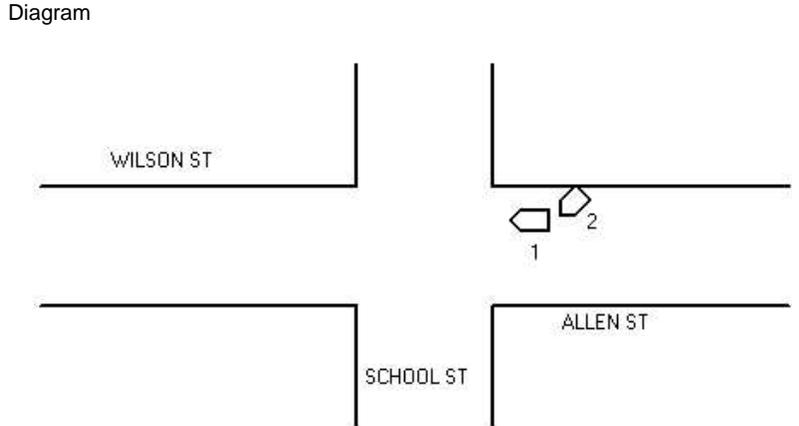
Narrative
 Unit #1 stopped at red light on Allen Street at School Street intersection. A tractor trailer was turning left from School Street onto Allen Street. Unit #1 felt that the tractor trailer would not make the turn so he looked in his driver's side rear mirror and saw nobody behind him. Unit #2 had pulled out of Cumberland Farms and was behind Unit #1. Unit #1 then backed into Unit #2.

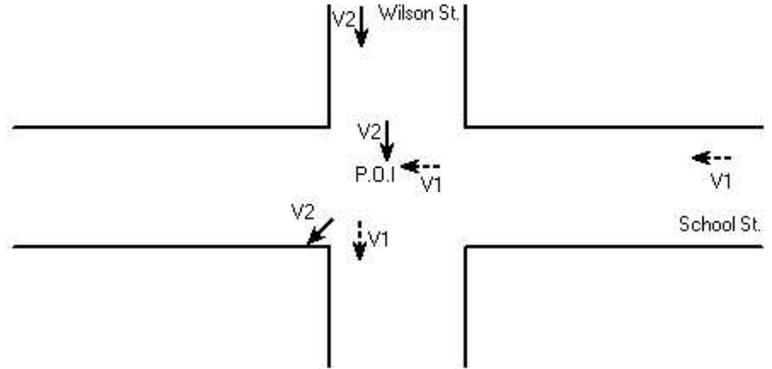
Diagram

V1 was driving south on School Street towards the intersection of School St. and Wilson St. V2 was driving east on Wilson St. towards the intersection of School St. Both V1 and V2 entered the intersection at the same time and collided. V1 struck the front driver's corner of V2 and V2 struck a light pole next to the intersection after the point of initial impact. Both operators stated they had a green light on their approach. One witness stated V1 had a green light on their approach and another witness stated V2 had a green light on their approach. The witness that stated V2 had a green light left the scene before she could be identified.

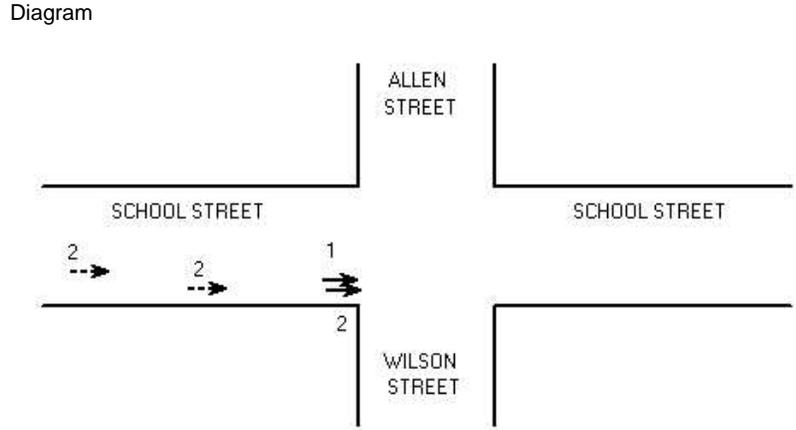
Narrative
Unit 1, traveling west on School Street, stopped at the red light at the intersection of Wilson Street. Unit 2, also traveling west on School Street, traveled to the right of the fog line alongside Unit 1, intending to turn right onto Wilson Street. Unit 1, was also intending to turn onto Wilson Street and as Unit 1 began to turn onto Wilson Street, Units 1 and 2 collided.
Driver 1 stated Unit 1's right turn directional was on. Driver 2 stated Unit 1's right turn signal was not on.
Driver 2 stated Unit 2's right turn signal was on.
Pavement between the fog line and granite curbing allows enough room for vehicles to turn right onto Wilson Street when westbound traffic on School Street is stopped. There is no traffic control device or painted crosshatch preventing such vehicle action....

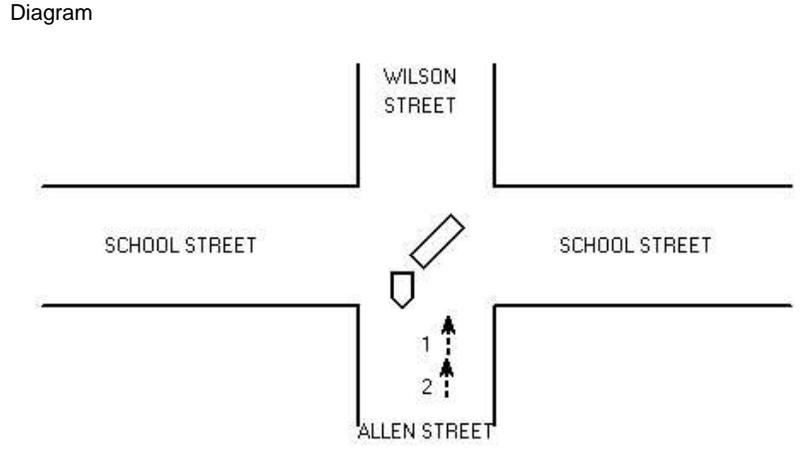
Narrative
Unit 1 and Unit 2 were stopped at the intersection of School Street for a red light while traveling westbound on Allen Street.
A tractor trailer truck was turning left onto Allen Street from School Street. Unit 1 backed up to give the tractor trailer truck more room to turn and backed into the front of Unit 2.
The sun was shining brightly but low from east to west.

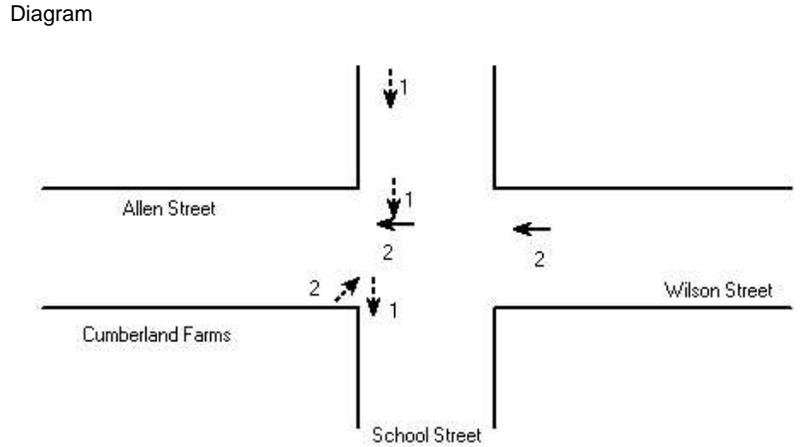
Narrative
Unit #1 was operating north on School Street and went through the intersection striking Unit #2. Unit #2 had been stationary at a red light on Wilson Street. Unit #2 started across School Street toward Allen Street and was struck on the passenger side. Witness who was behind Unit #2 confirmed she had green light. Unit #1 operator stated his light was green. Unit #2 operator stated she was stopped and proceeded when light turned green. No other witnesses.

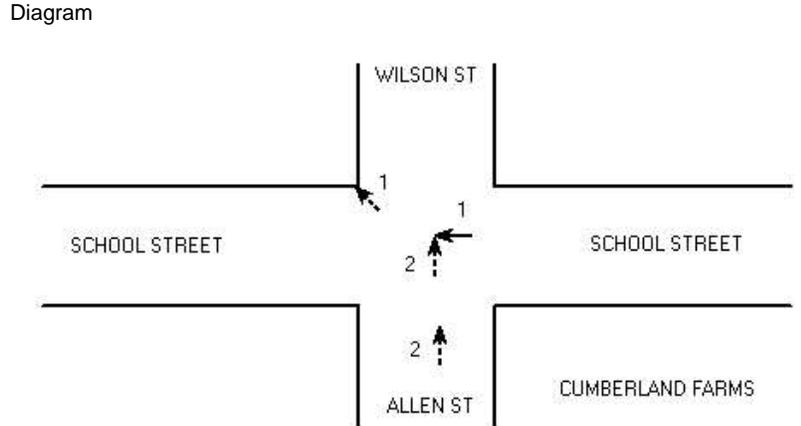
Narrative
 Unit 1 was traveling southbound on School Street approaching the intersection of Allen Street with a yellow blinking traffic signal. Unit 2 was traveling westbound on Allen Street crossing School Street towards Wilson Street, while failing to stop at the blinking red light. Unit 2 collided with Unit 1, sending Unit 1 into the traffic signal pole.

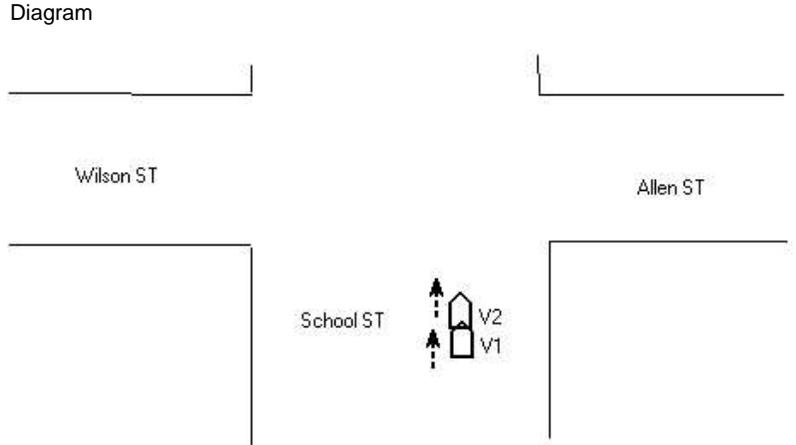
Narrative
V1 stopped behind V2 at traffic light facing north on School ST at the intersection of School ST, Wilson ST and Allen ST. The traffic light turned green, V1 accelerated faster than V2. V1 hit the rear of V2.

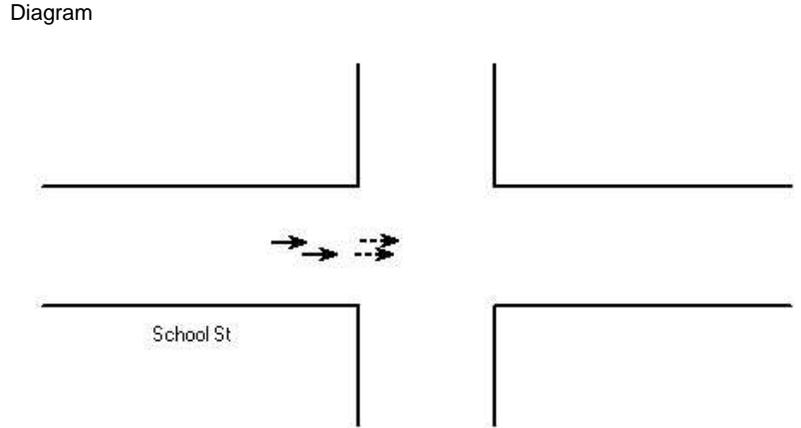
Narrative
Unit #1 making left turn from School Street onto Allen Street. Unit #2 passed Unit #1 by driving into the opposite lane of travel and continued straight on School Street. Unit #1 was turning onto Allen Street from School Street and collided with Unit #2. Unit #2 had an unknown passenger in the vehicle that fled prior to PD arrival.

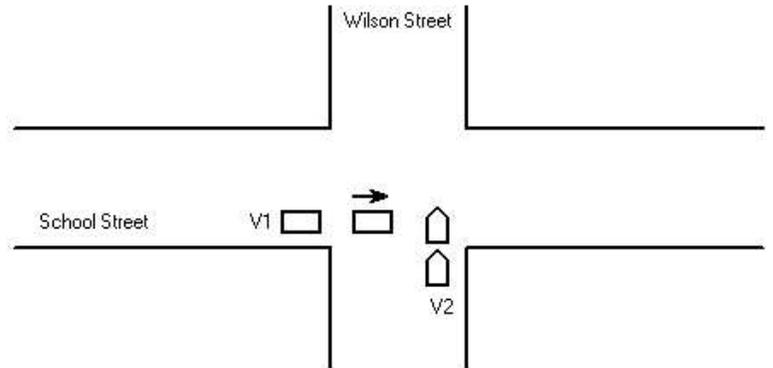
V1 was traveling north on School School and failed to stop for the red light striking V2 traveling through the intersection from Allen Street.

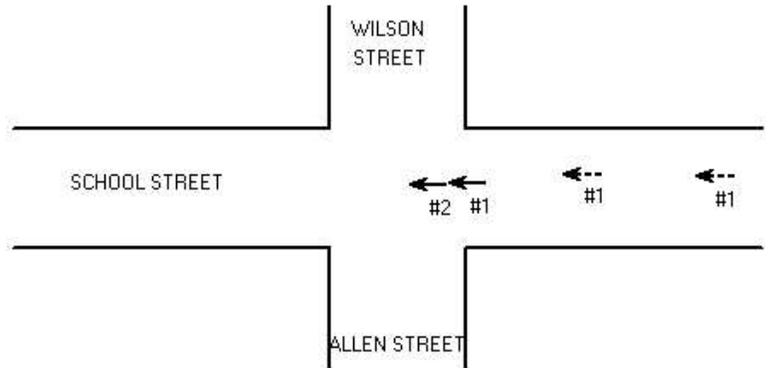
Unit 2 slowed and stopped in the intersection preparing to turn left onto Allen Street but was waiting for on-coming traffic to clear. Prior to traffic clearing, Unit 1 struck the rear of Unit 2.

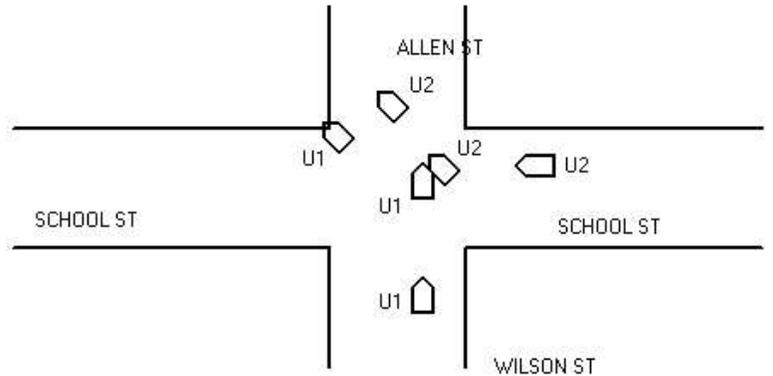
U1 TRAVELING ON WILSON STREET TOWARDS SCHOOL STREET. U2 ON SCHOOL STREET MAKING A RIGHT TURN ONTO ALLEN STREET. U1 DID NOT NOTICE THE RED TRAFFIC LIGHT AND DID NOT STOP. U1 COLLIDED WITH U2 DURING IT'S RIGHT TURN. HEAVY DAMAGE TO BOTH VEHICLES. U1 OPERATOR ADMITTED TO NOT STOPPING FOR THE TRAFFIC LIGHT.

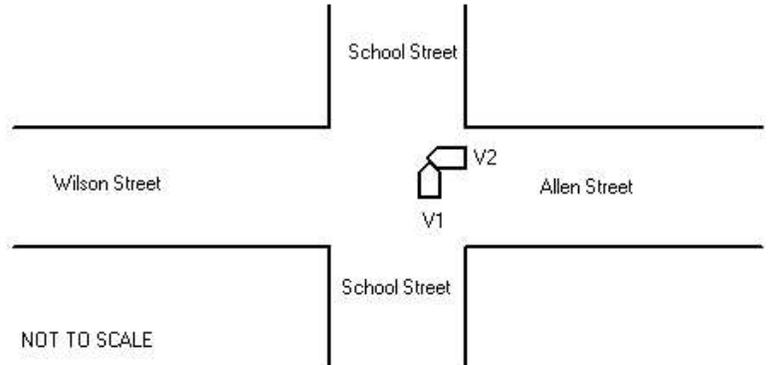
Vehicle 1 traveling north on School Street. Unknown tractor trailer unit in front of Vehicle 1 made a right turn on red onto Allen Street. Vehicle 1 continued straight through intersection. Vehicle 2 traveling west on Allen Street and entered intersection on green light. Vehicle 1 struck Vehicle 2.

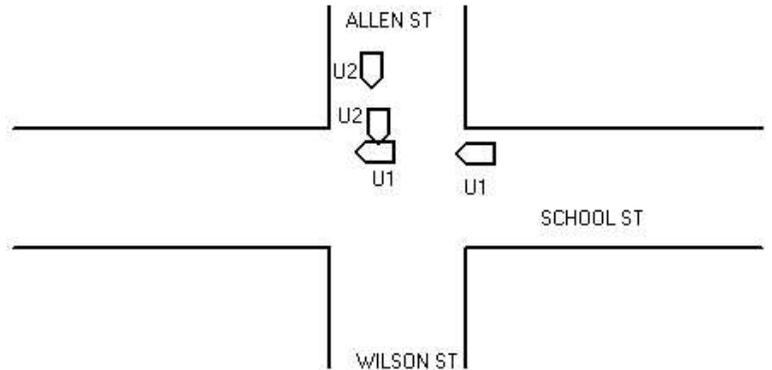
U1 TRAVELING EAST ON SCHOOL STREET. U2 TRAVELING NORTH ON ALLEN STREET. U1 FAILED TO STOP AT THE RED LIGHT AND CROSSED IN FRONT OF U2 GOING FROM ALLEN ST TO WILSON ST. O1 ADMITTED TO FT STOP FOR THE LIGHT.

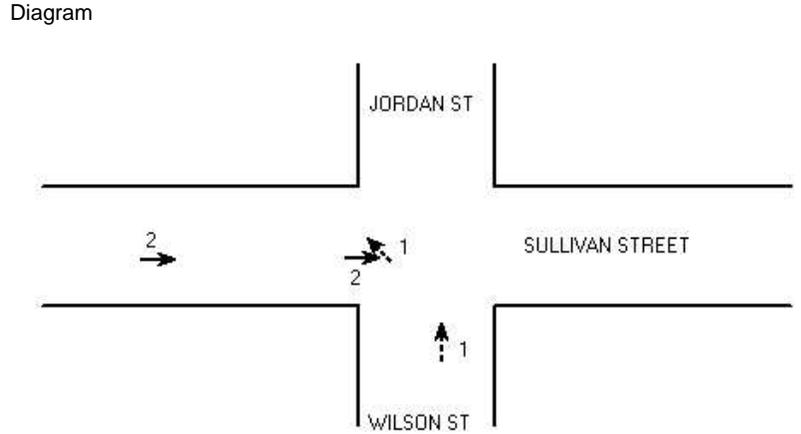
Narrative
 Unit 1 was making a left turn onto Sullivan Street from Wilson Street. Unit 2 traveling northbound on Sullivan Street failed to stop at the stop sign and struck the side of Unit 1.

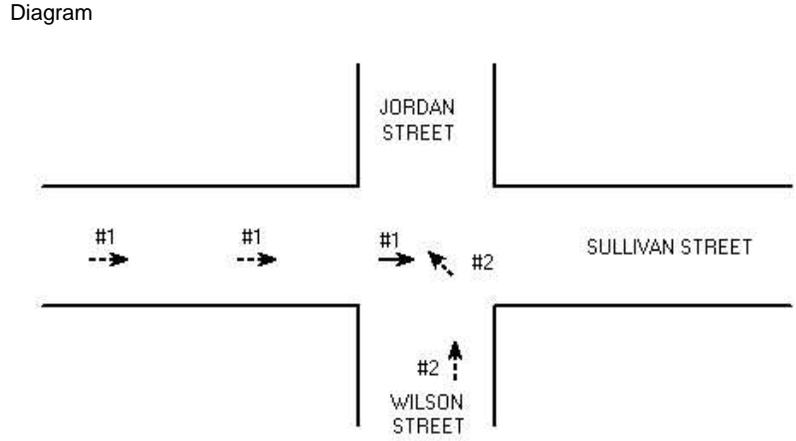
Narrative
Unit 2 was making a left turn onto Sullivan Street from Wilson Street. Unit 1 was traveling westbound on Sullivan Street and failed to stop at the stop sign, striking Unit 2.

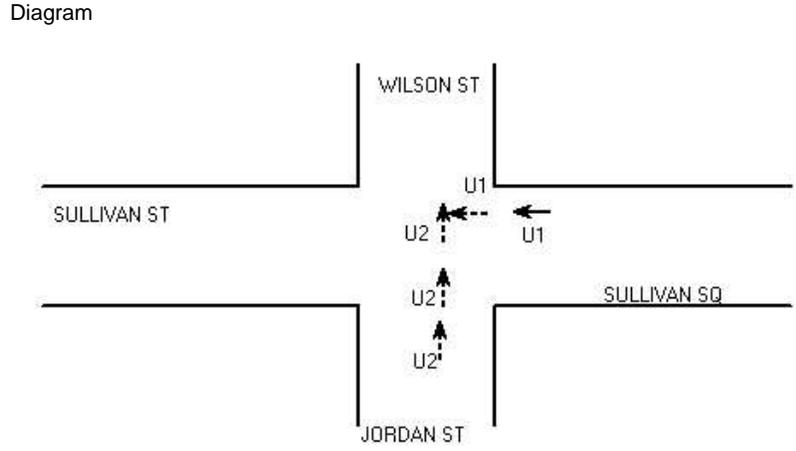
Narrative
U1 WAS STOPPED ON SULLIVAN SQ. HEADING THROUGH THE INTERSECTION ONTO SULLIVAN ST. U2 WAS STOPPED ON JORDAN ST HEADING THROUGH TO WILSON ST.
U2 SAW U1 STOPPED A CAR LENGTH BACK FROM THE STOP SIGN AND ENTERED THE INTERSECTION. U1 ACCELERATED AND BROADSIDED U2. OPERATOR 1 STATED SHE DIDN'T SEE U2 AND MAYBE "BLACKED OUT." RESCUE CHECKED BOTH PARTIES AND THEY SIGNED OFF SAYING NO TREATMENT WAS NEEDED. BOTH VEHICLES WERE DRIVEN FROM THE SCENE.

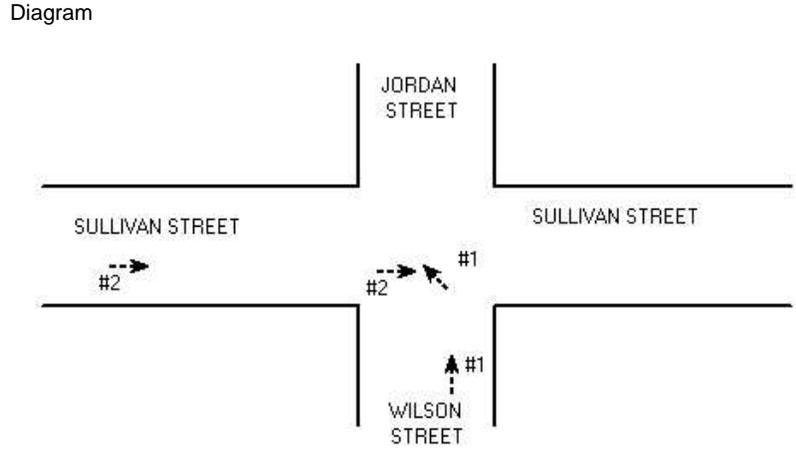
Narrative
Unit 1 entered the intersection after stopping at the stop sign on Wilson Street. Unit 2 did not stop at the stop sign and collided with Unit 1.

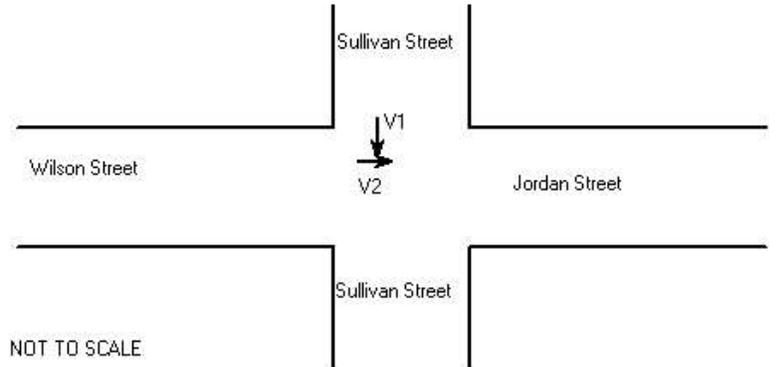
Vehicle 2 was making left turn from Wilson Street onto Sullivan Street. Vehicle 1 was traveling north on Sullivan Street. Vehicle 1 did not stop at stop sign and struck vehicle 2.

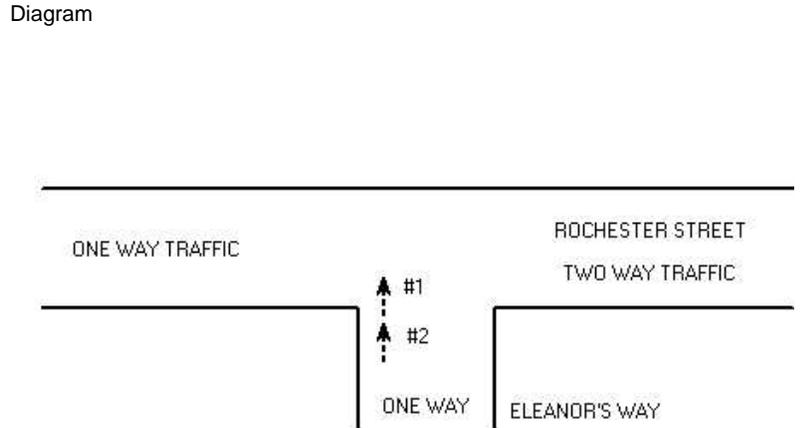
Narrative
 Unit 1 stopped to make a left turn onto Rochester Street. Unit 1 began but stopped again as Driver 1 observed in-bound traffic on Rochester Street. When Driver 2 observed Unit begin to go after having stopped, Unit 2 began to go while Driver 2 looked right to make sure it was clear. While Driver 2 was looking right to be sure it was clear, he did not realize Unit 1 stopped again and tapped the rear of Unit 1. Unit 2 had no evidence of vehicle contact, while Unit 1's rear bumper skin was creased ever so slightly and observable only with oblique lighting.

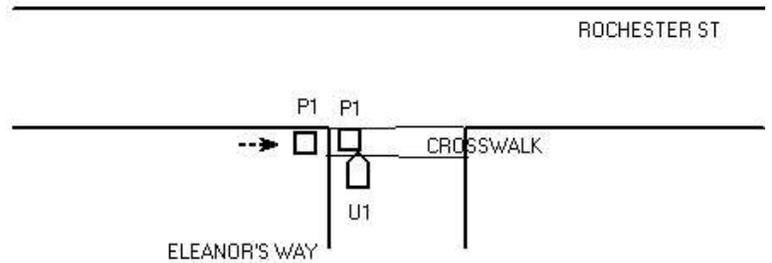
U1 WAS STOPPED ON ELEANOR'S WAY PREPARING TO TURN LEFT ONTO ROCHESTER ST. PED1 WAS ALSO ON ELEANOR'S WAY (TOWN HALL SIDE) CROSSING IN THE MARKED CROSS WALK TO CONTINUE ONTO ROCHESTER STREET. U1 LOOKED RIGHT FOR ONCOMING TRAFFIC AND SEEING NONE BEGAN TO MAKE THE LEFT TURN. U1 FAILED TO SEE PED1 AND COLLIDED WITH SUBJECT. MINOR INJURIES TO PED1. WITNESS CONFIRMED STORIES OF BOTH INVOLVED SUBJECTS.

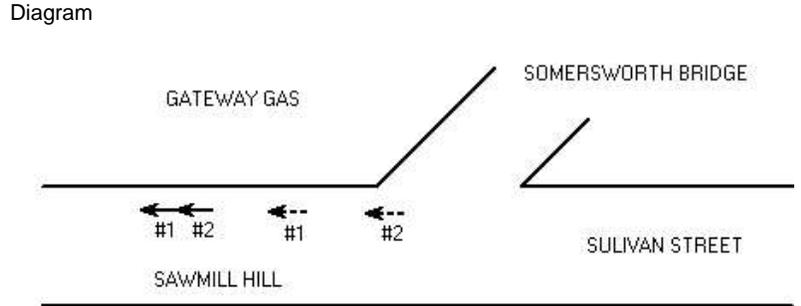
Narrative
Unit 1 slowed in traffic on Sawmill Hill Road in front of Gateway Gas. Unit 2 rear-ended Unit 1.

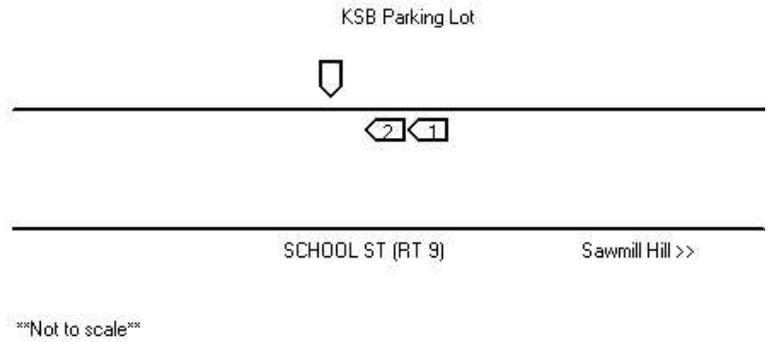
U1 OPR said U2 stopped very suddenly, and he did not see a turn signal.

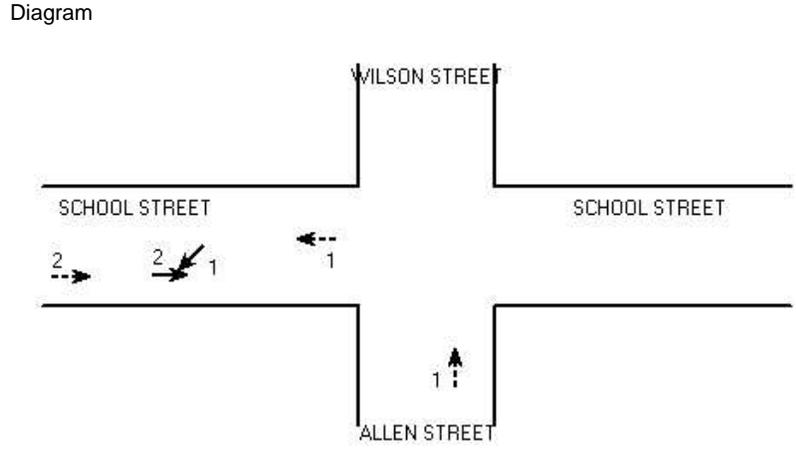
Narrative
 Unit 1 was turning left onto School Street from Allen Street when Unit 1's right rear strut broke. The right rear tire folded onto the roadway sending Unit 1 out of control to the left and into the front of Unit 2 which was slowing in traffic.

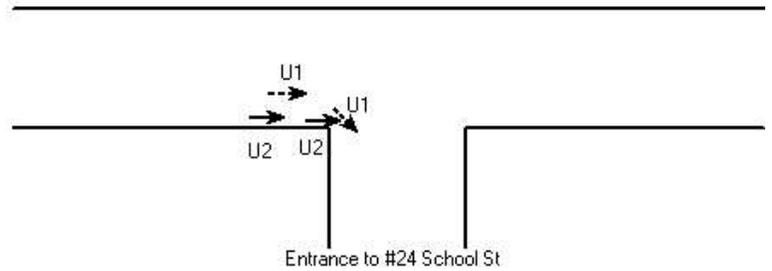
Diagram

U1 AND U2 WERE BOTH EAST ON SCHOOL STREET APPROACHING THE ALLEN STREET INTERSECTION. U1 SLOWED / STOPPED TO MAKE A RIGHT TURN INTO #24 SCHOOL STREET (RESIDENCE). U2 FOLLOWING BEHIND PULLED INTO THE BREAKDOWN LANE TO PASS THE STOPPED TRAFFIC AND GET UP TO THE INTERSECTION. AS U1 TURNED, HE DID NOT SEE U2 IN THE BREAKDOWN LANE AND BOTH VEHICLES COLLIDED. U2 STRUCK THE CENTER PASSENGER SIDE OF U1.

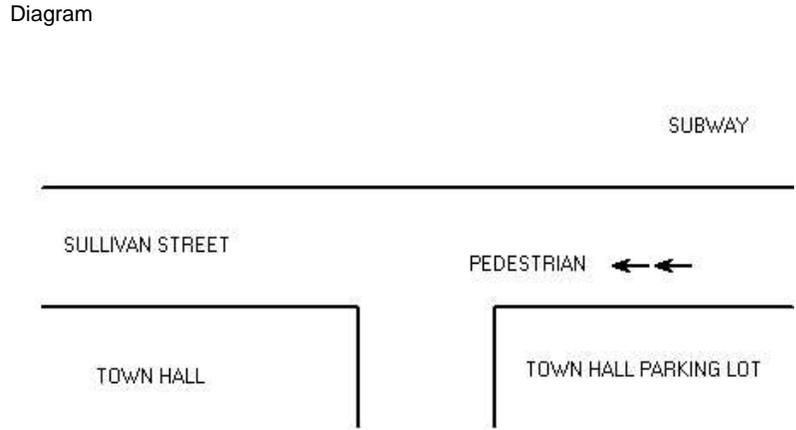
Narrative
Unit 1 stopped for a pedestrian crossing in the crosswalk. Unit 2 could not stop in time and rear-ended Unit 1.

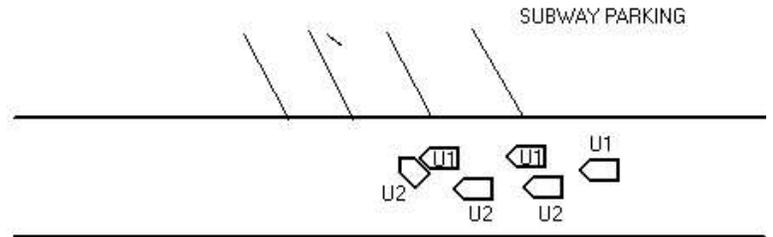
Diagram

U1 WAS FOLLOWING U2 ONTO SULLIVAN SQ FROM THE TRAFFIC LIGHTS. THIS IS A ONE LANE ROAD IN FRONT OF SUBWAY. U2 SIGNALLED INTENTIONS TO TURN INTO A PARKING SPACE AT SUBWAY. U1 ATTEMPTED TO GO AROUND U2 ON THE RIGHT SIDE AS O1 STATED SHE THOUGHT U2 WAS CONTINUING STRAIGHT. U1 COLLIDED WITH U2 DURING IT'S TURN.

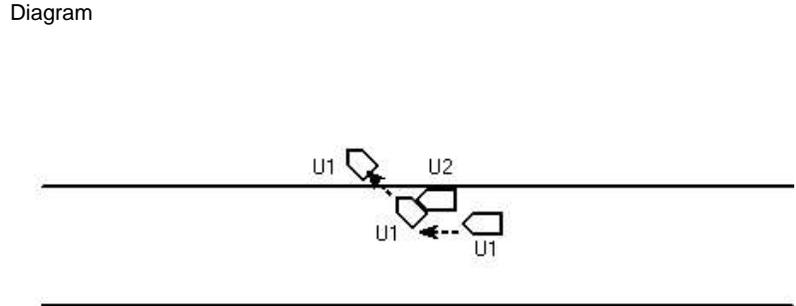
Narrative
U1 WAS TRAVELING ON WILSON STREET PREPARING TO TURN RIGHT INTO THE CHURCH PARKING LOT. U2 WAS PARKED LEGALLY ON WILSON ST IN FRONT OF THE CHURCH. U1 FAILED TO CLEAR THE PARKED VEHICLE AND CLIPPED THE LEFT FRONT CORNER OF U2. U2 WAS UNOCCUPIED AT THE TIME OF THE CRASH.

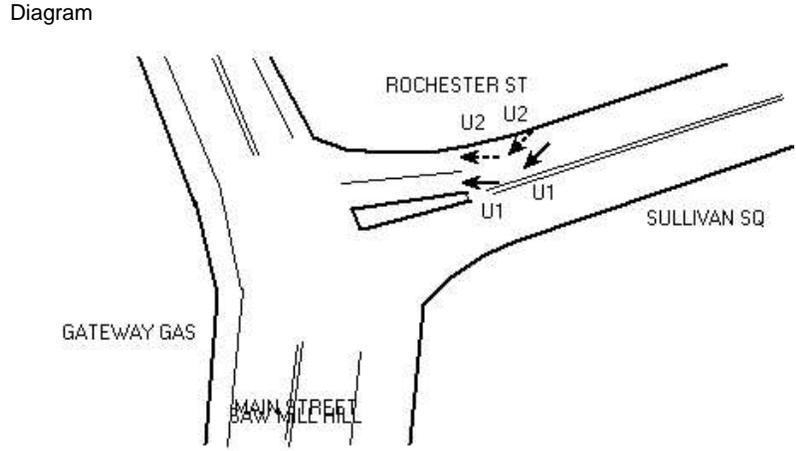
Narrative
U1 AND U2 WERE ON ROCHESTER STREET HEADING TOWARDS THE TRAFFIC LIGHT AT INTERSECTION OF SULLIVAN SQ. U2 WAS IN THE RIGHT LANE AND U1 WAS IN THE LEFT LANE. BOTH VEHICLES COLLIDED WITH EACH OTHER. OPERATOR'S GOT OUT AND SPOKE, THEN O1 LEFT THE SCENE IN U1 TOWARDS SCHOOL STREET.

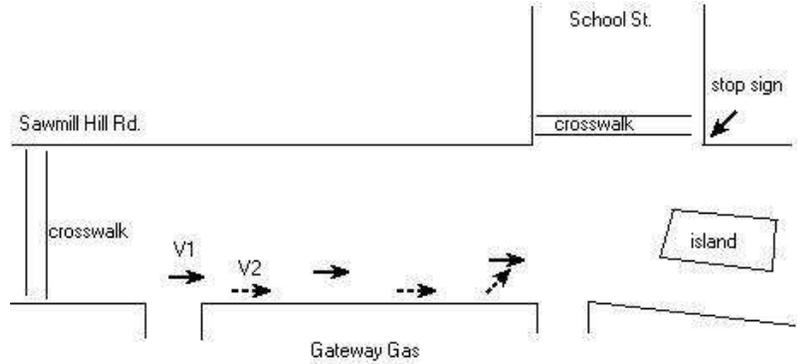
Diagram

V1 was travelling east on Sawmill Hill Road and was going to continue turning north on to School Street. V2 was travelling east on Sawmill Hill Road and was going to turn on to School Street as well. V2 (cyclist) made a left turn without looking or making a signal to go north on School Street at the same time V1 did and V1 struck V2.

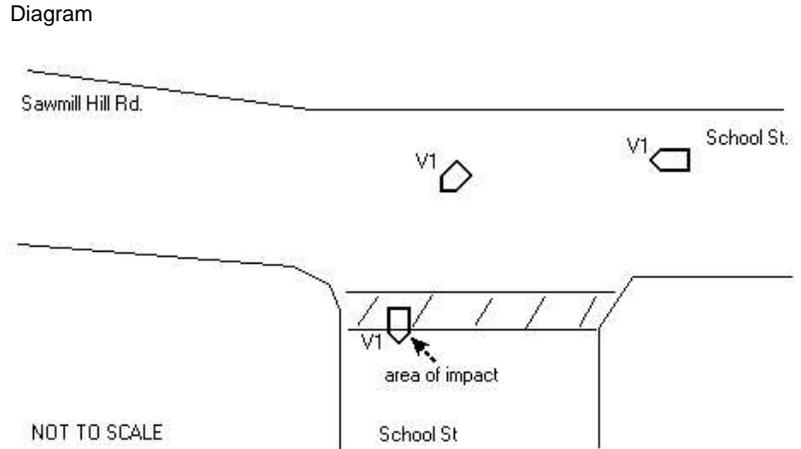
Narrative
 V1 was driving east on School Street. V1 struck a pedestrian that was crossing School Street on a marked cross walk.
