Re: Phase I Environmental Site Assessment Update
Former Prime Tanning Facility
North Berwick, Maine
St.Germain Collins File No.: 3352.2

St.Germain Collins is providing you with this Phase I Environmental Site Assessment (ESA) update on the above-referenced property (Site—see Figure 1, Site Location Map). As you are aware, we completed a Phase I ESA for this Site in May 2012 (see Attachment A, 2012 Phase I ESA), but the ASTM International E1527-05 standard (Phase I Environmental Site Assessment Process) and US EPA's All Appropriate Inquiry law requires that it be updated after 180 days in order to maintain environmental liability protection under Federal law.

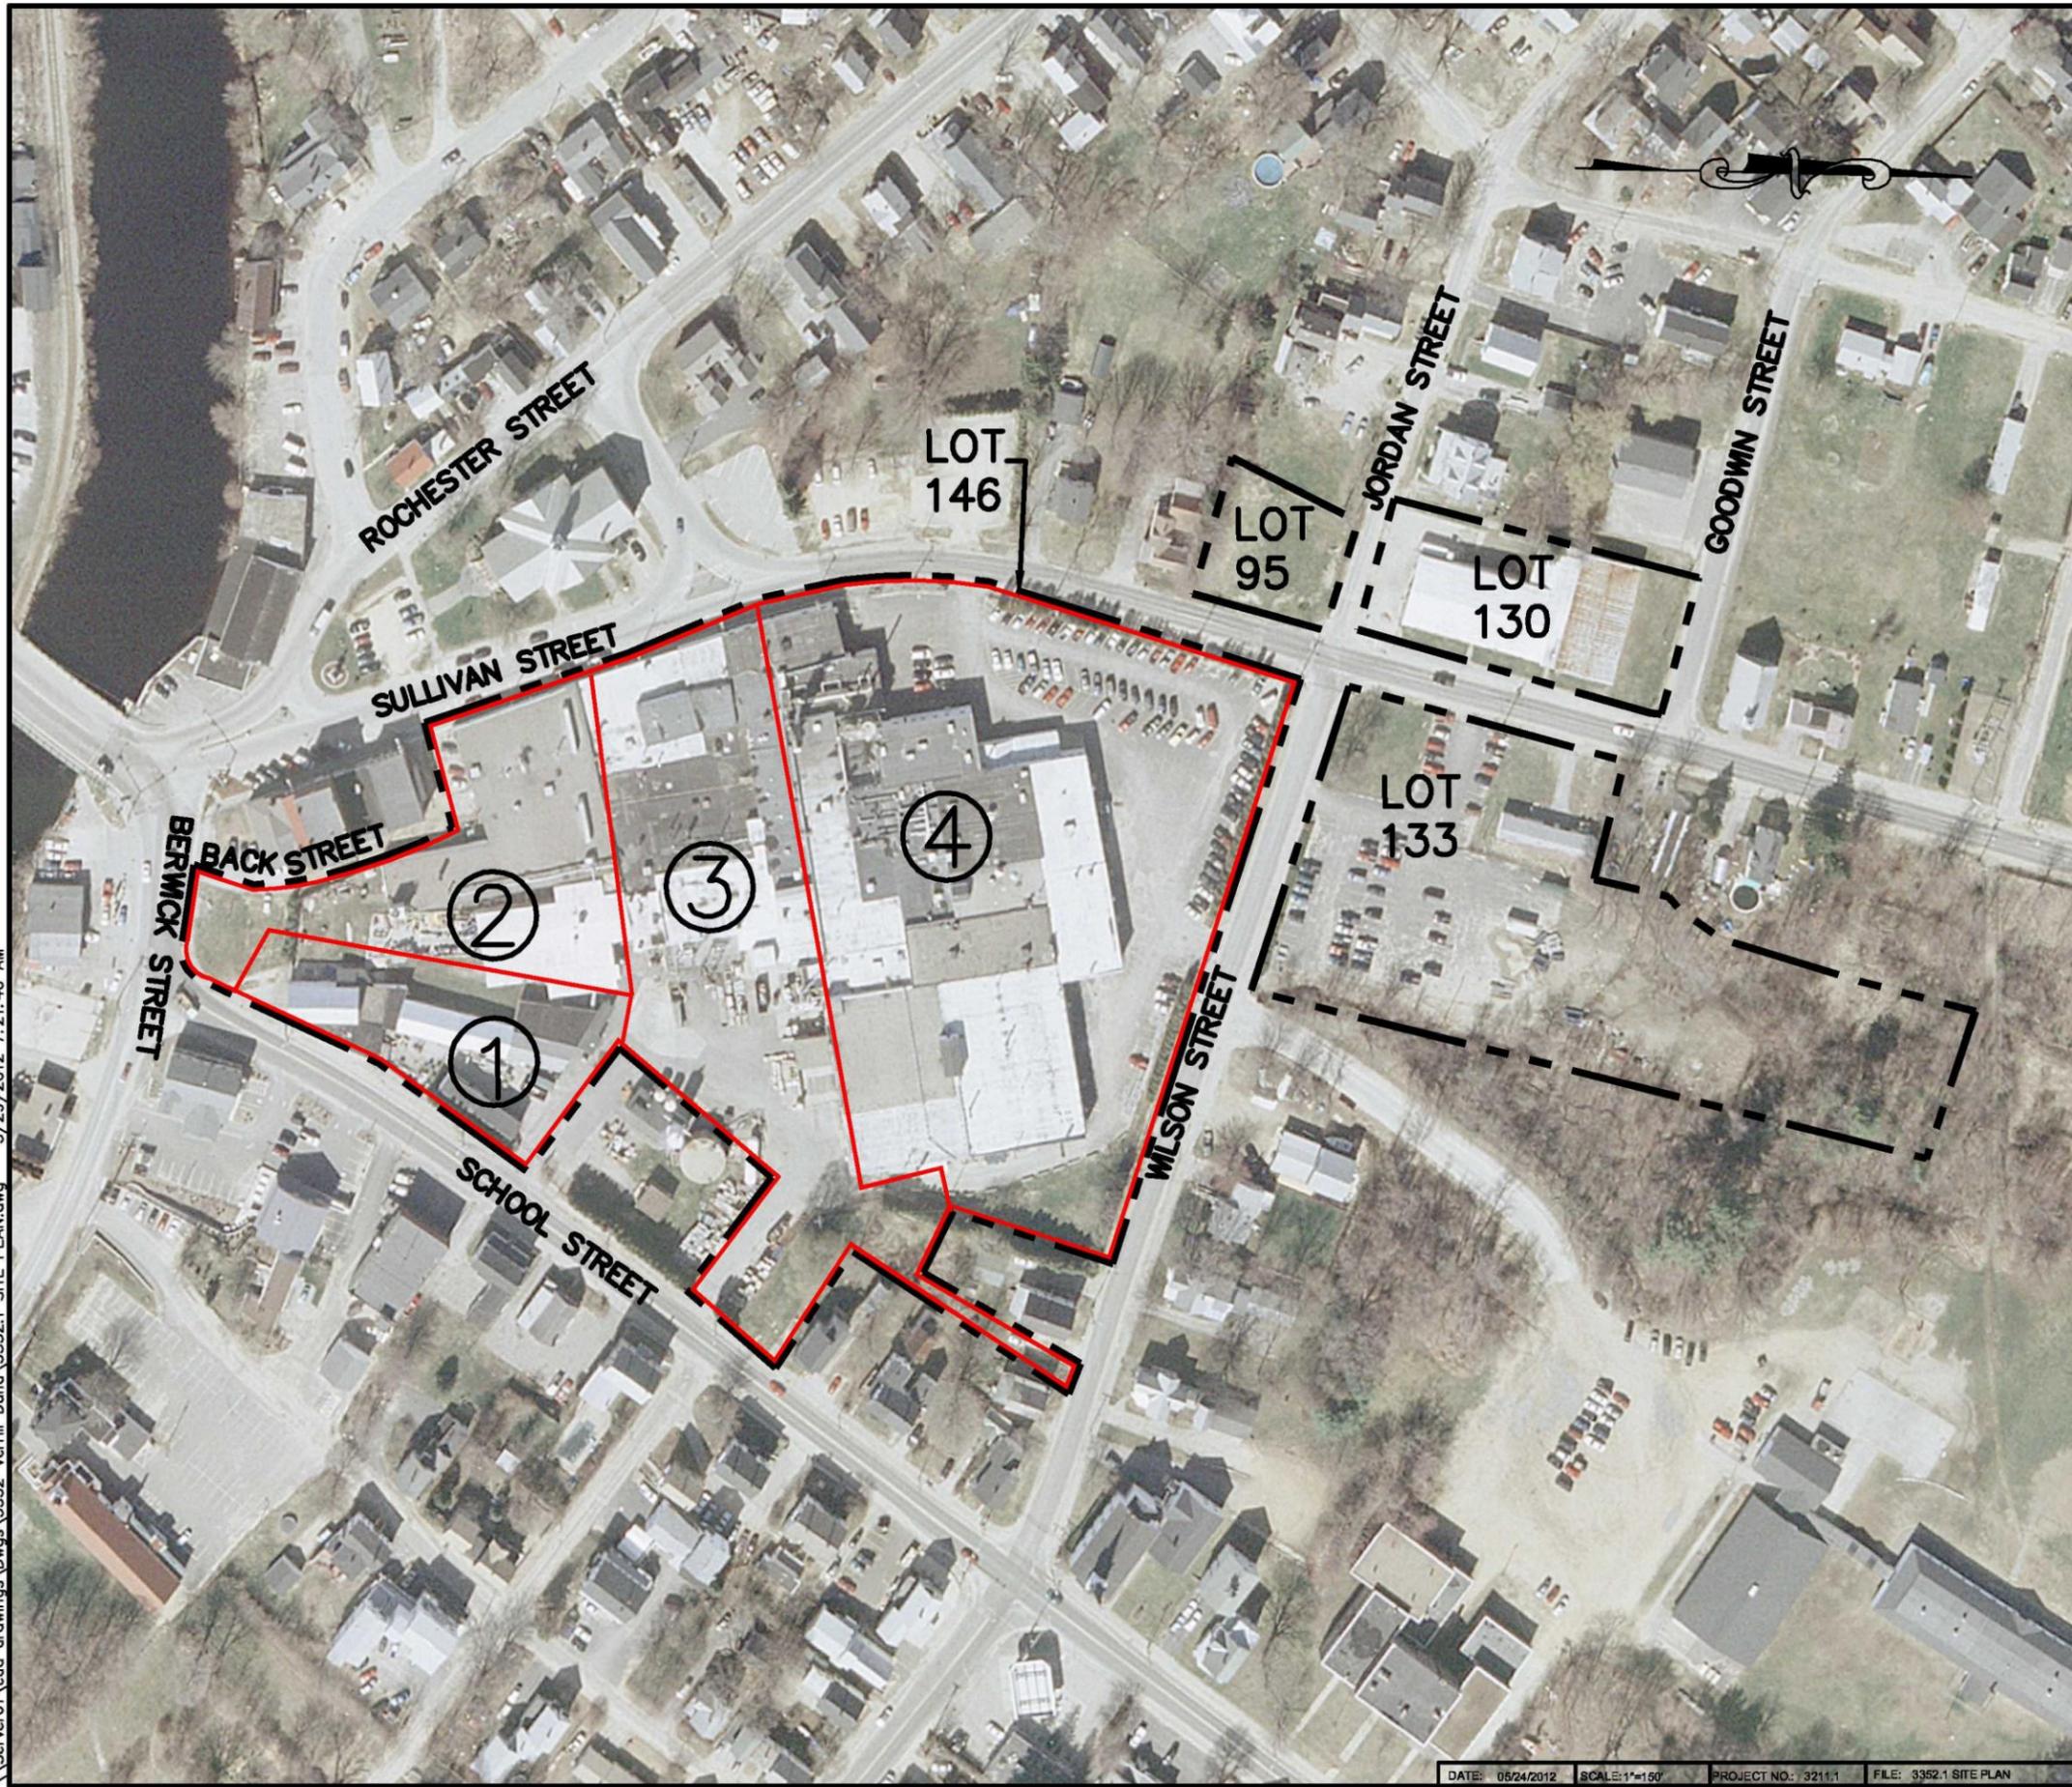
FIGURE 2

Mr. Labbe led St.Germain Collins on an inspection of all interior portions of the main building on Lot 146 and the building on Lot 130. The exterior parts of Lots 146, 130, 133 (no buildings), and 95 (no buildings) were also inspected (see Figure 2, Site Plan).

LEGEND:
 - - - - - SITE BOUNDARIES (APPROXIMATE)

The Site is located in a mixed residential and commercial area with Site features shown on **Figure 2, Site Plan**. The Site consists of four parcels with the largest one mostly covered with a complex of buildings formerly used as a leather tannery. Two of the three smaller lots are essentially undeveloped, while the fourth lot contains a warehouse.

Sumps	Located throughout the facility, no product or sheen observed on the water's surface.
Obstructions Limiting Observations?	None
Tannery Central (see Figure 2 for location)	
Uncontrolled Solid Waste	None
Odors	None

INTERIOR OBSERVATIONS	
MAIN TANNERY BUILDING (LOT 146)	
Date of Site Visit 5/22/2012	
Obstructions Limiting Observations?	None
Second floor of Tannery North (see Figure 2 for location)	
Uncontrolled Solid Waste	None
Odors	None
Pools of Liquids	None
Drums or Buckets?	Three empty 55-gallon drums, one 55-gallon drum full of metal parts, and five 5-gallon buckets of paint, tile mastic, and one with unknown contents. All containers in good condition.
Unidentified Substances	One 5-gallon bucket without a label located in the electrical shop.
Transformers	Two dry type transformers
Stains or Corrosion	None
Drains	None
Sumps	None
Obstructions Limiting Observations?	None
Carpenter Shop (see Figure 2 for location)	
Building Description	The carpenter shop is a wood framed structure with a slab-on-grade foundation.
Uncontrolled Solid Waste	None
Odors	None
Pools of Liquids	None
Drums or Buckets?	Five 5-gallon buckets of tile mastic, one pallet of 5-gallon buckets of roof coating, four 5-gallon totes of fire retardant, and five empty 55-gallon drums, one full 35-gallon drum of waste oil in the fork truck repair area. All containers in good condition.
